28th RCI International Convention and Trade Show

How to Survey a Slate Roof

Joseph Jenkins

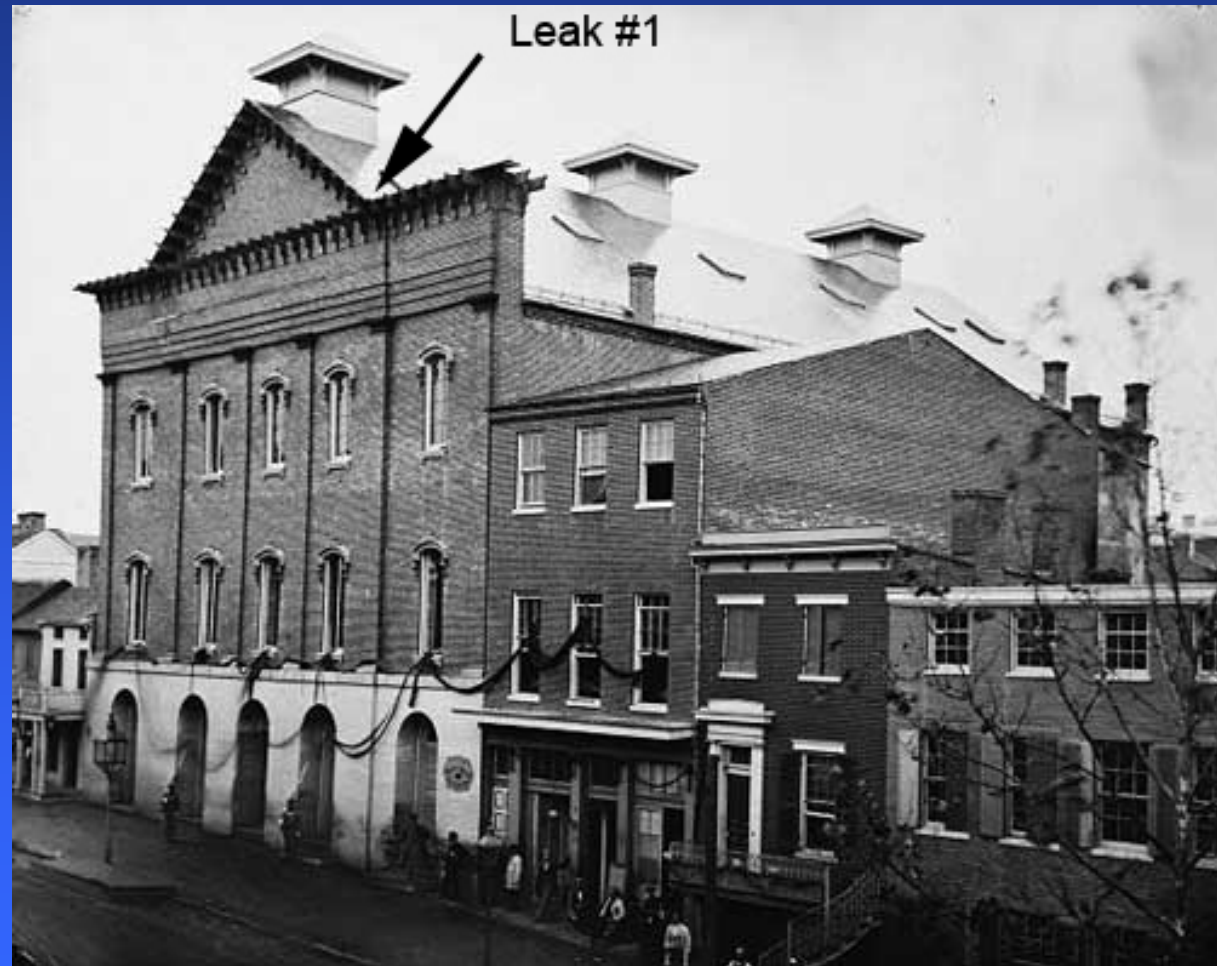
The main leak was in the copper parapet coping joint where a soldered seam had popped open.

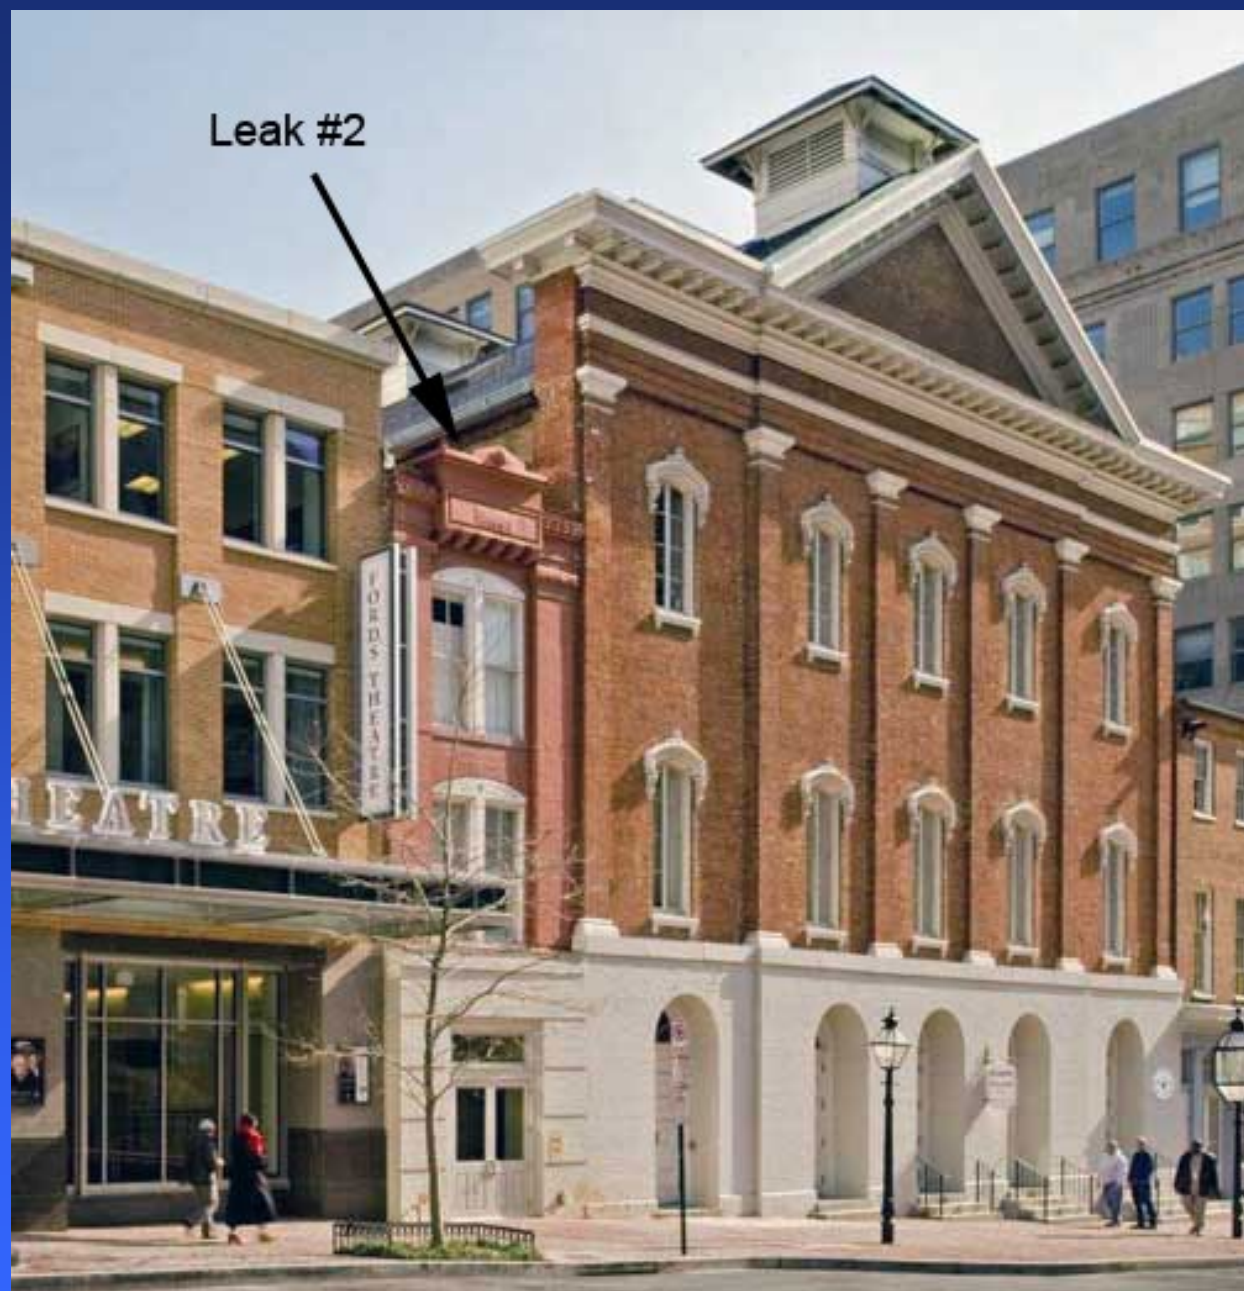
The second leak was in a wall flashing on the adjacent building.

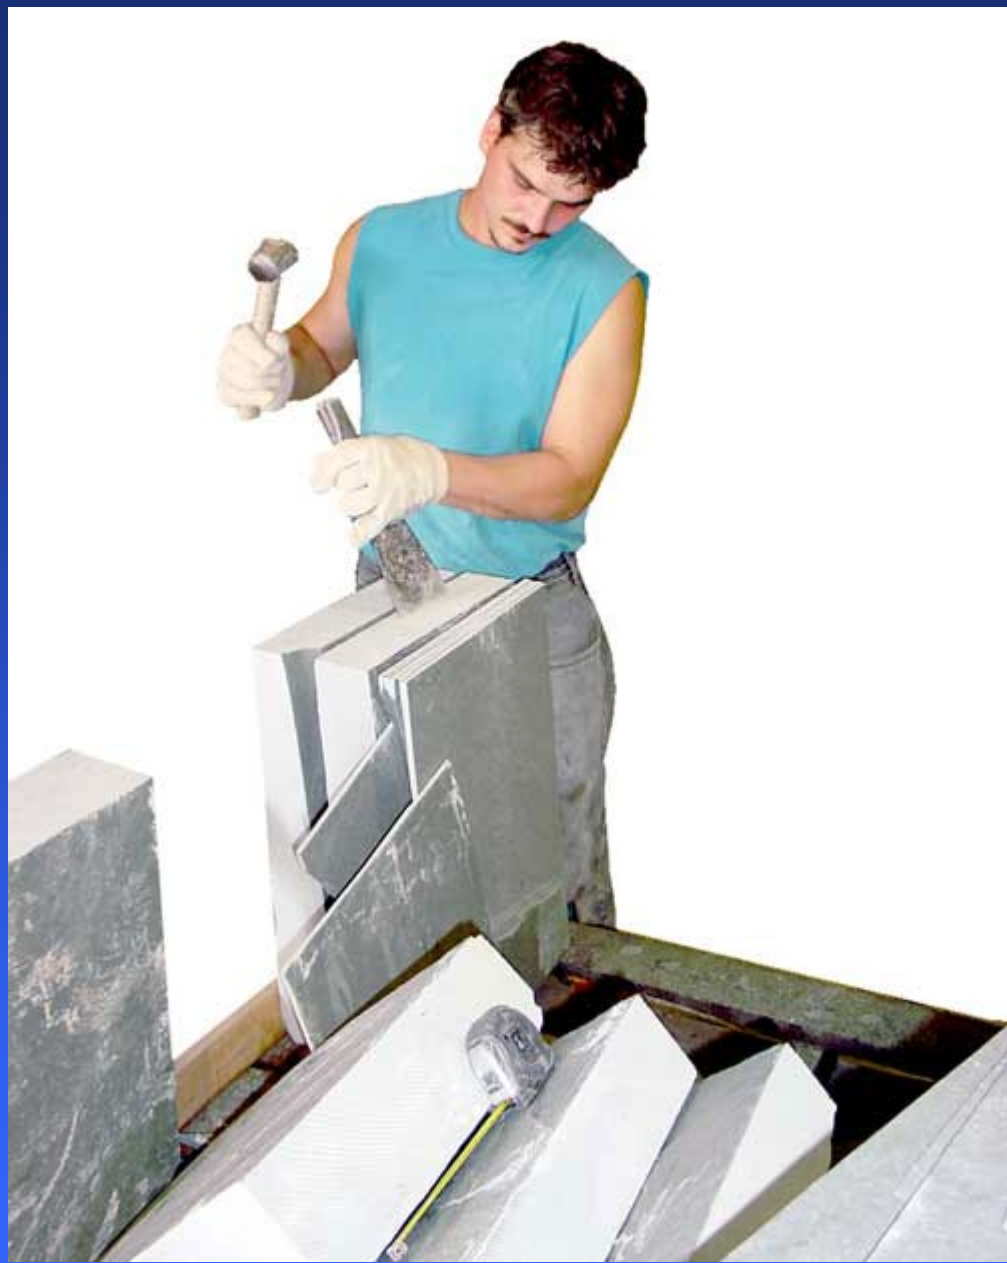
Blocks are
hand-split
into shingles.

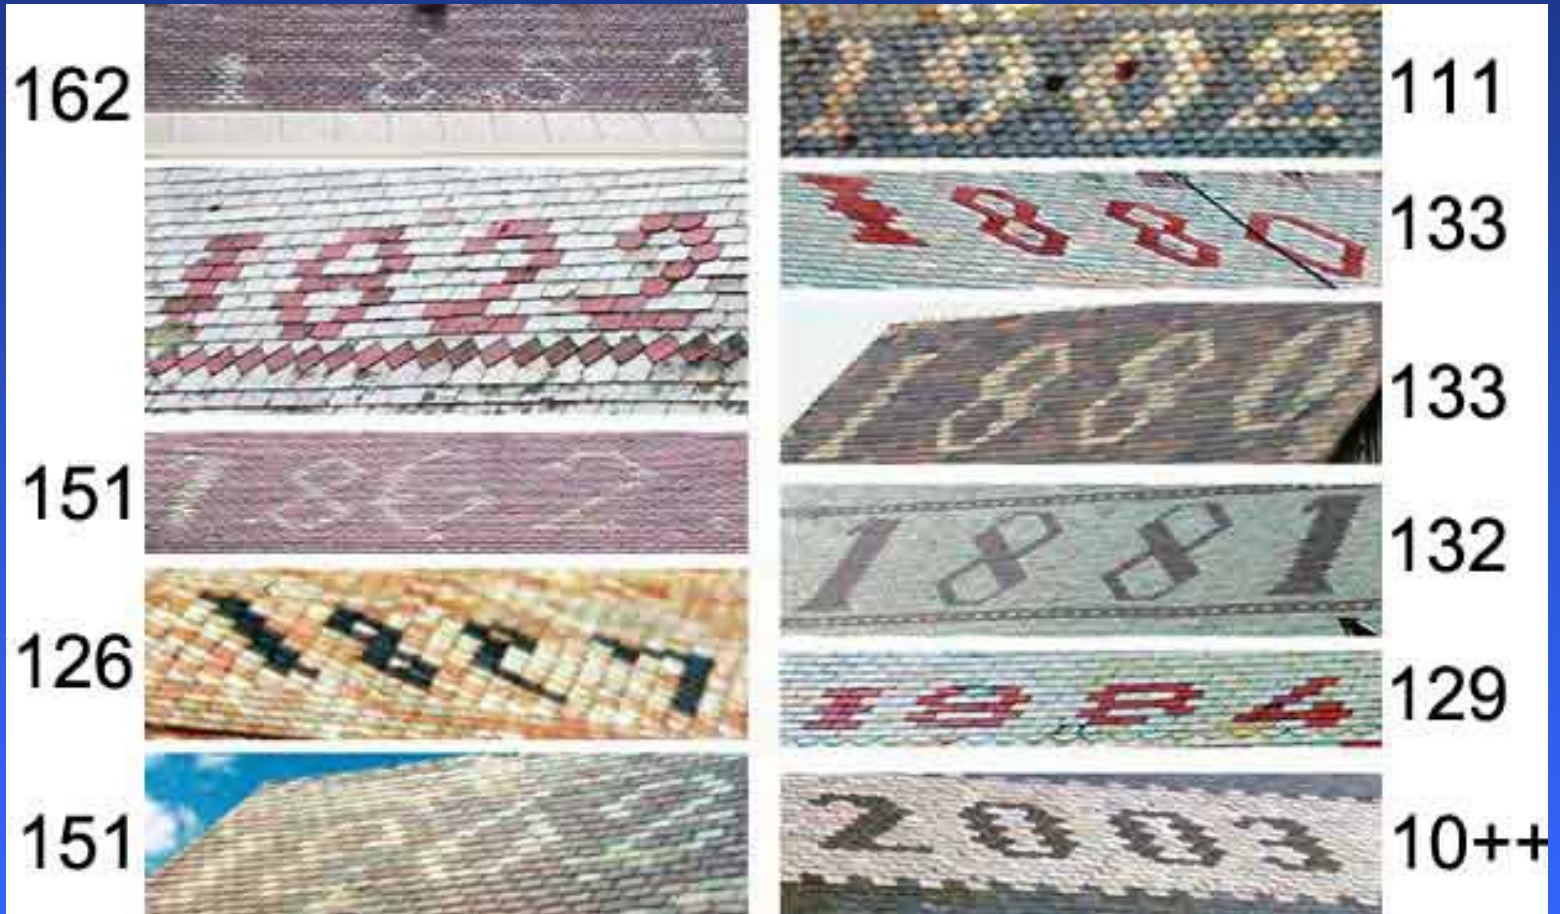
S1 slates can last 200 years. The ages of these roofs are shown in the margins.

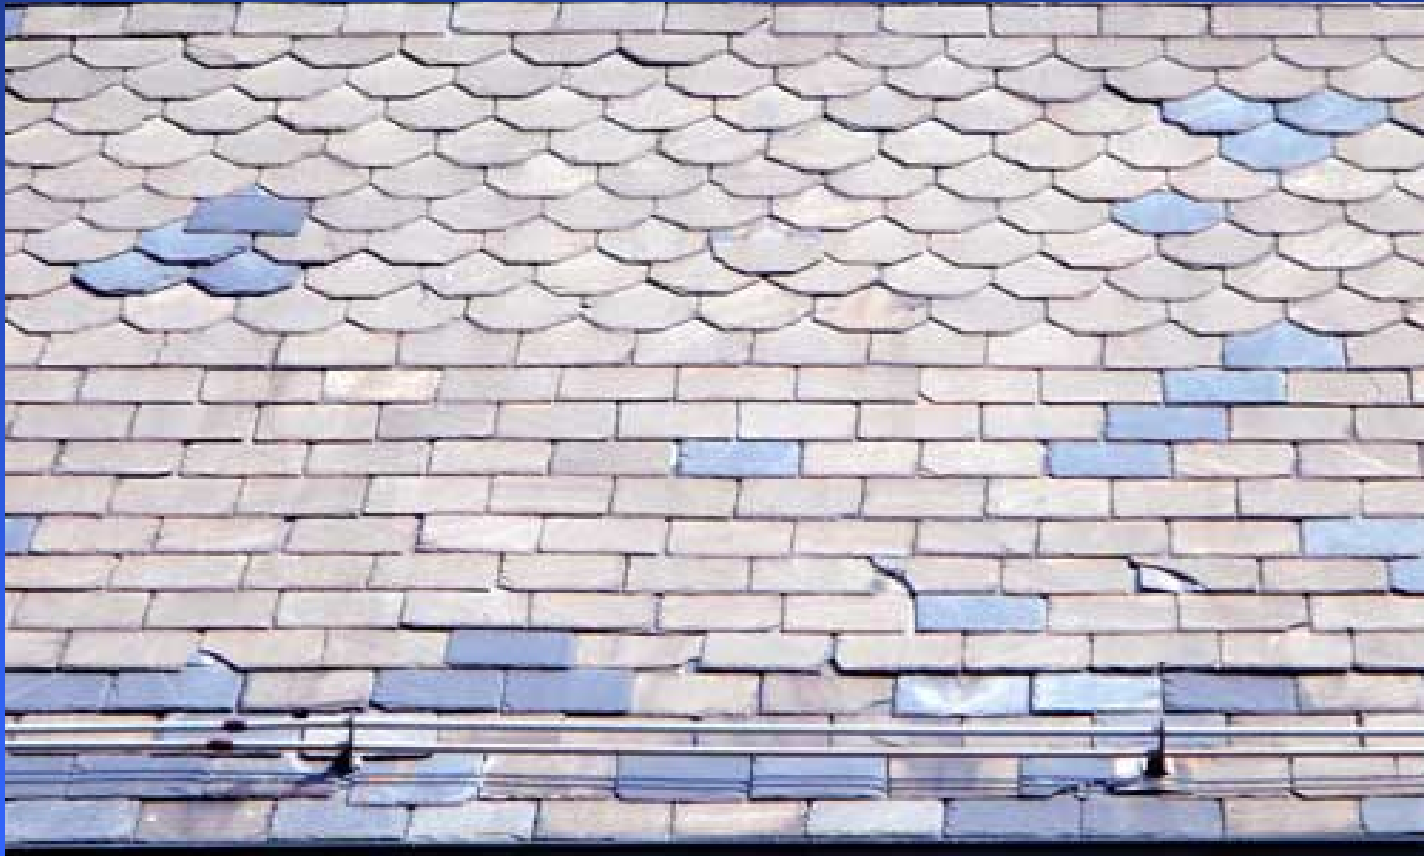
Buckingham, VA slates, 1879 (134 Years old, with repairs):

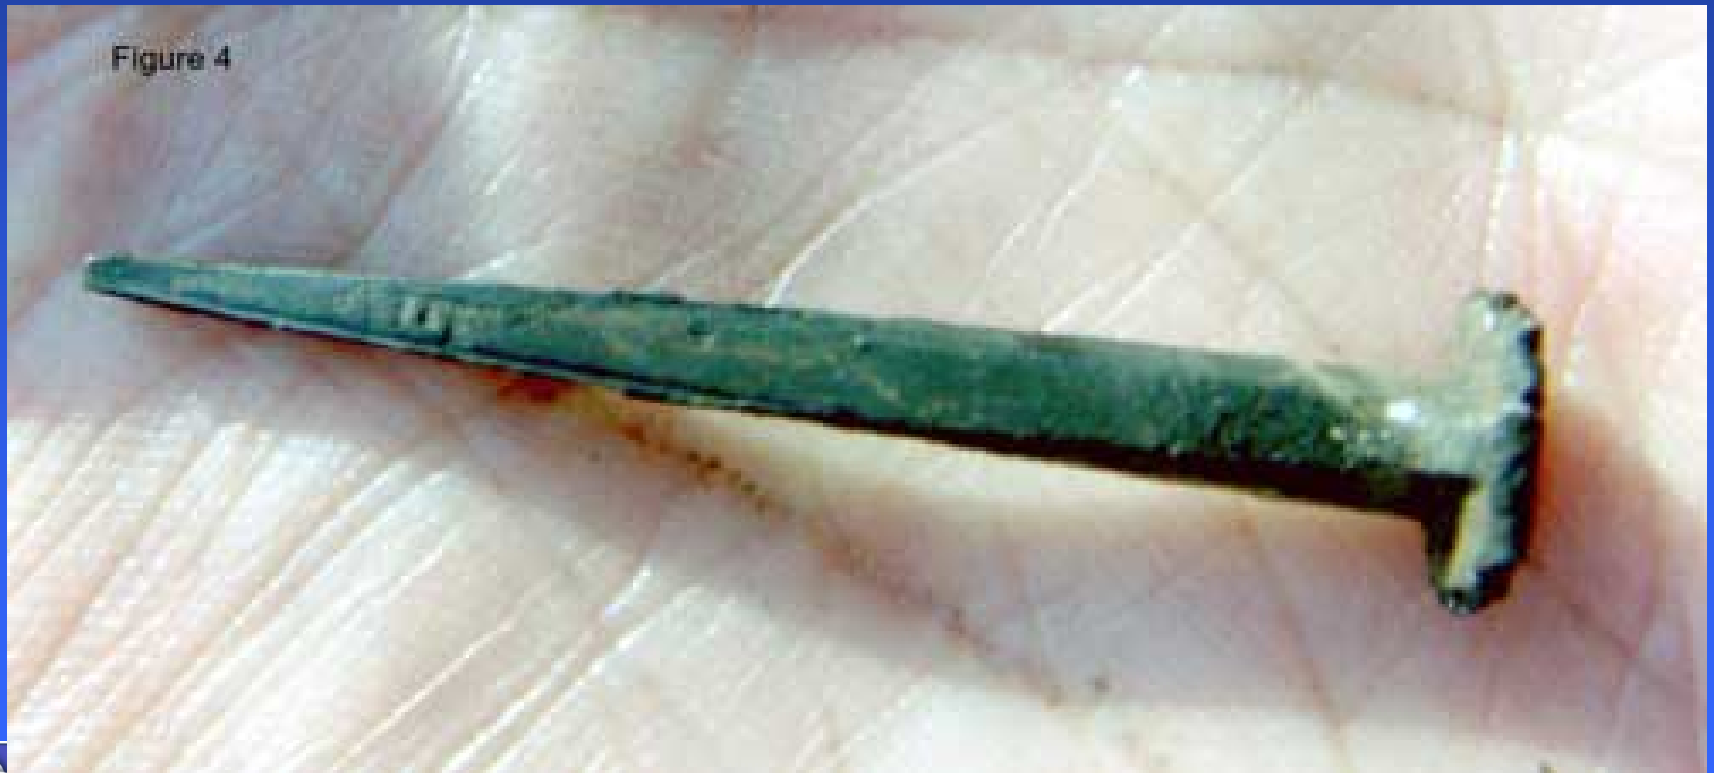
The original slating nails (134 years old, no deterioration).

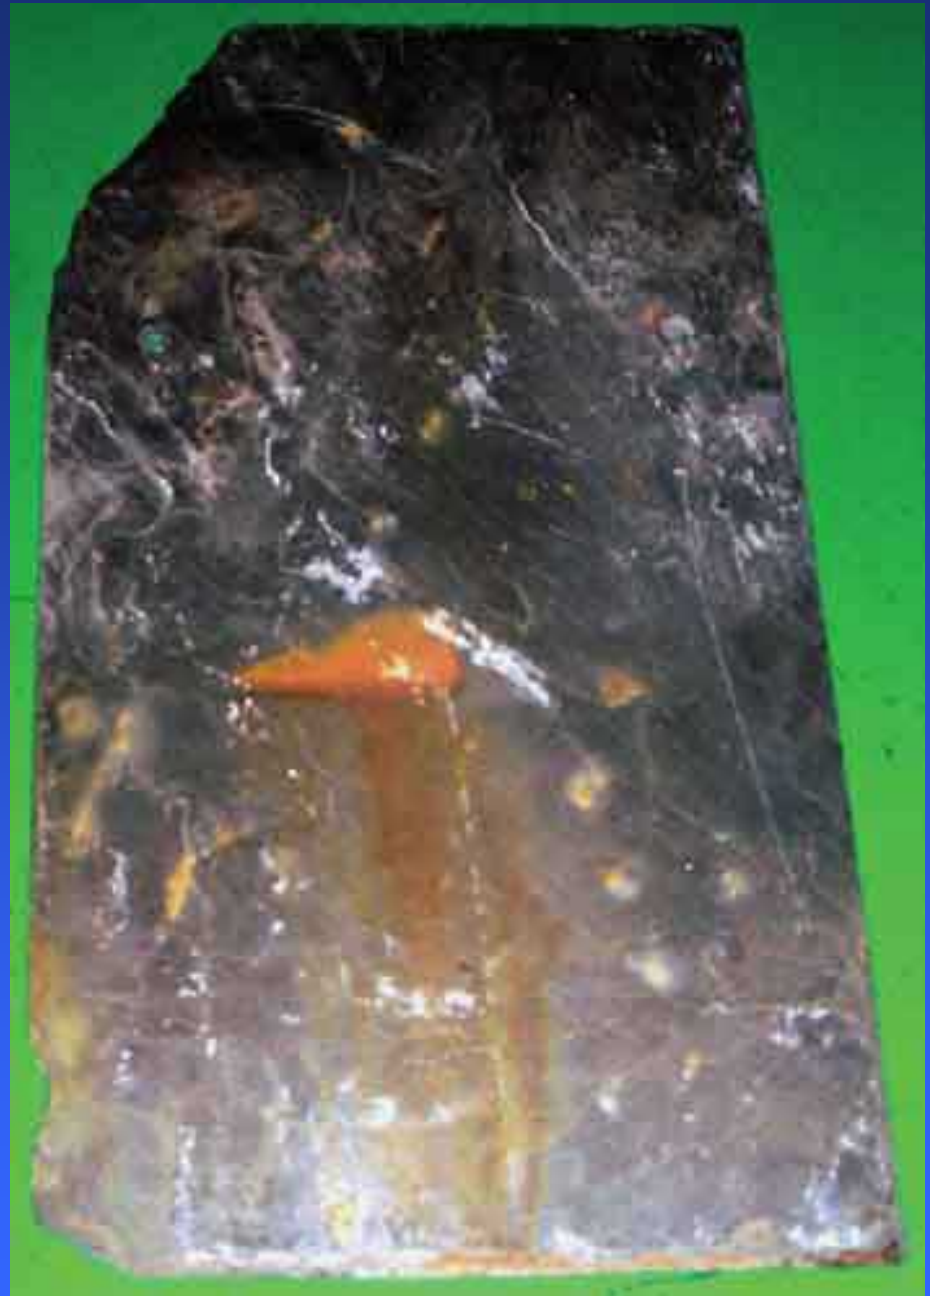
Spanish
slates can
have rust
problems.

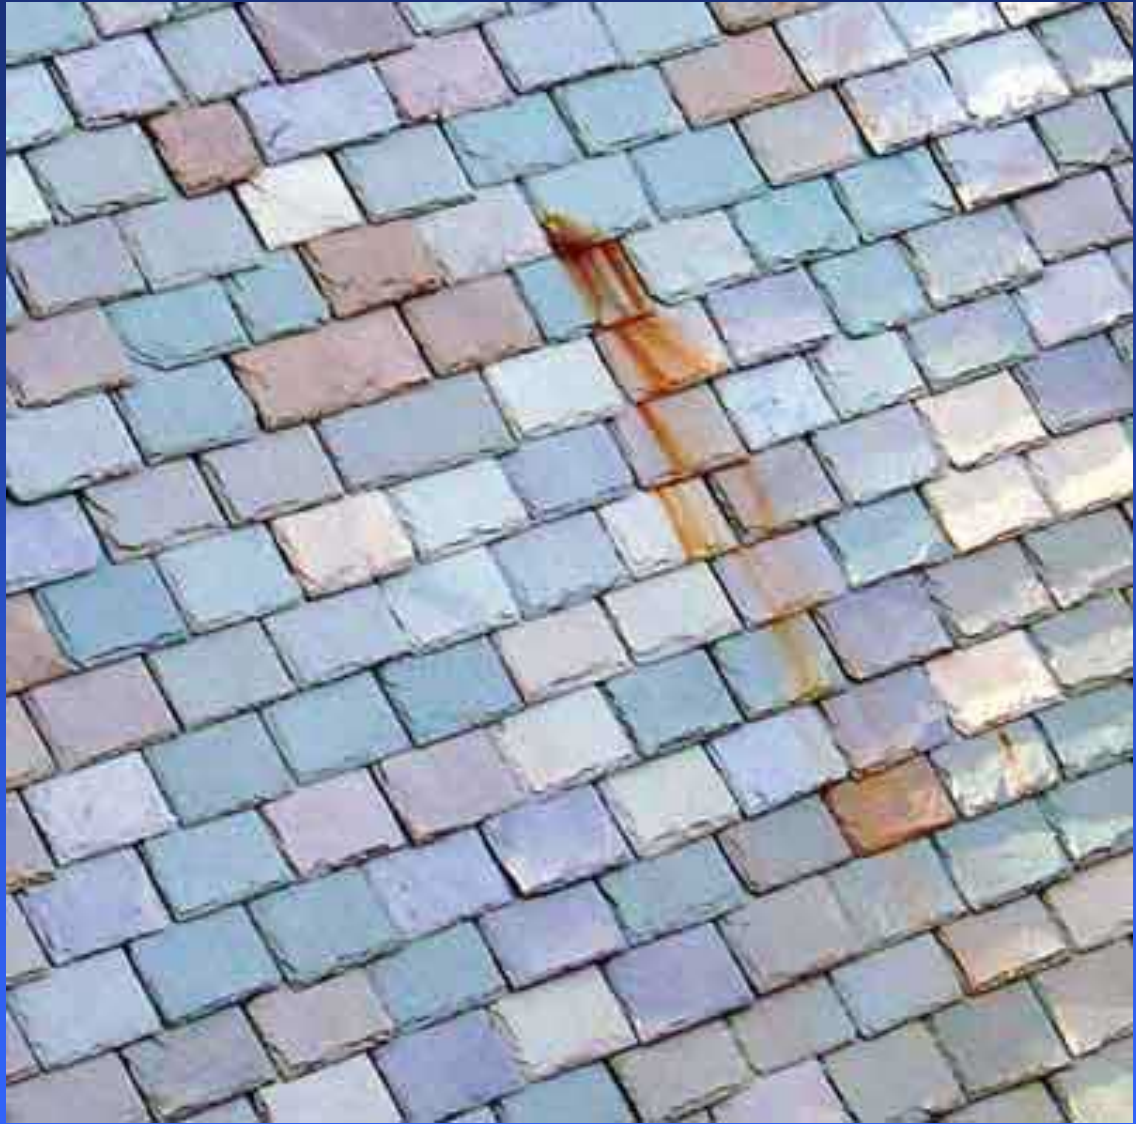
American
slates can also
have rust
problems, but
it's much less
likely.

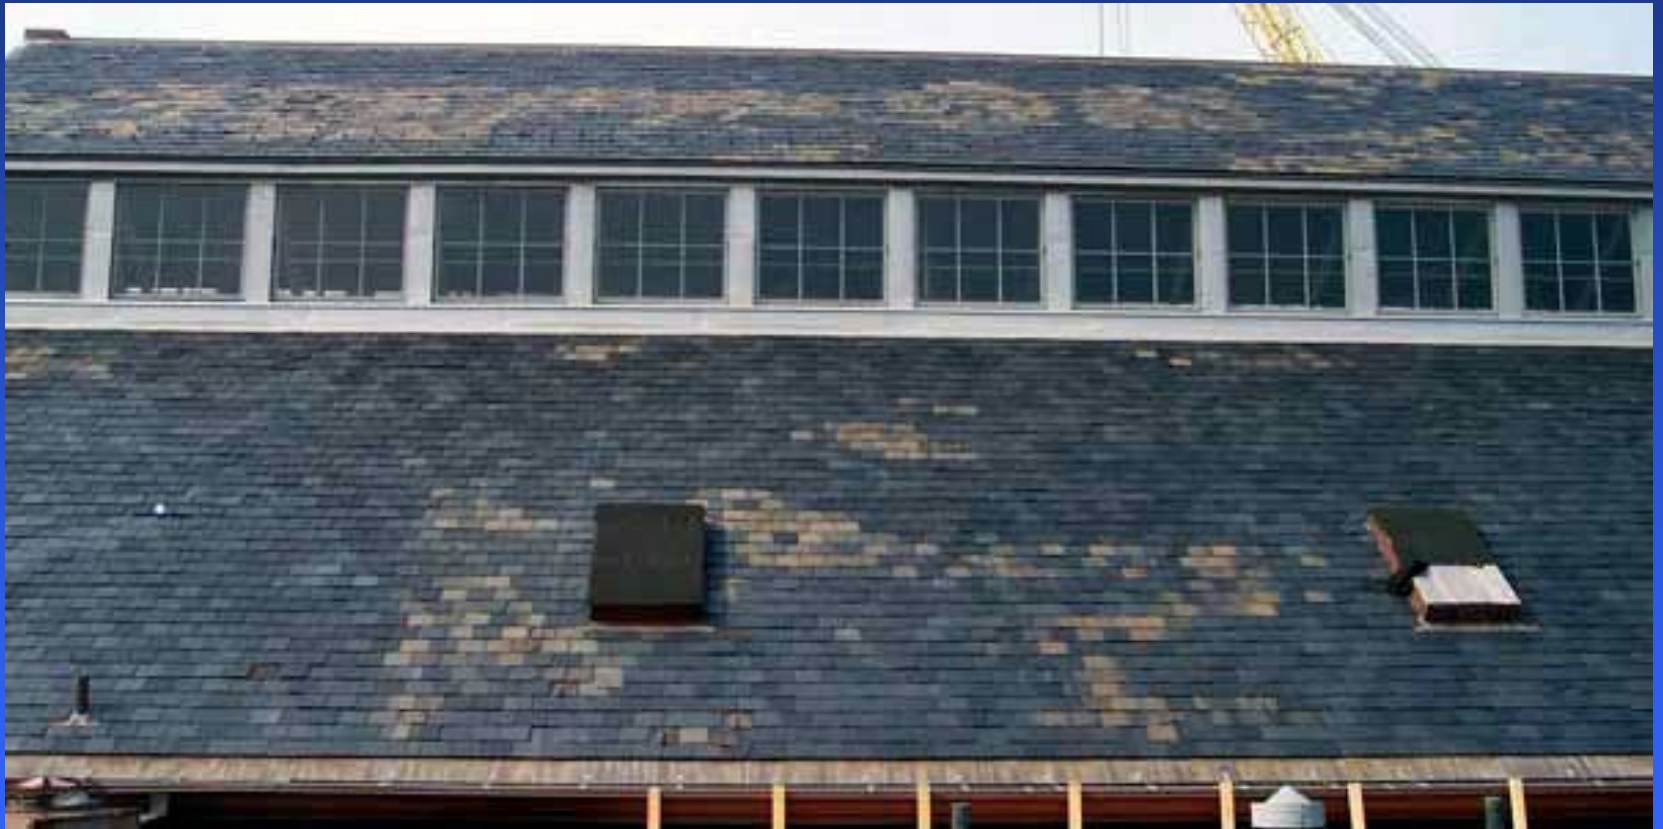
Defective Chinese black slates:

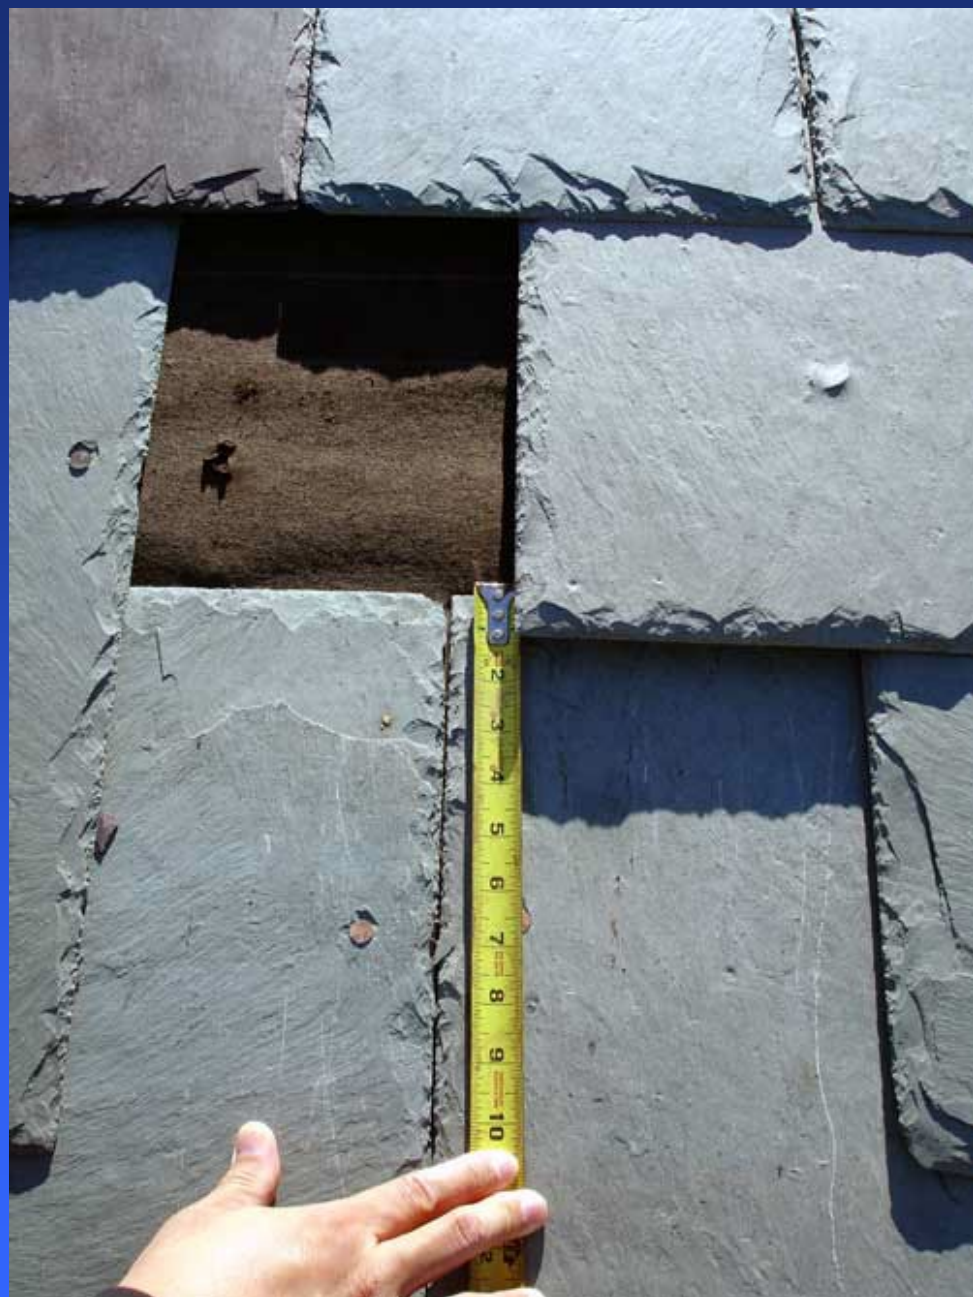
Headlap is generally 3 inches. Here you see one inch of headlap.

This new slate roof had to be removed and replaced.

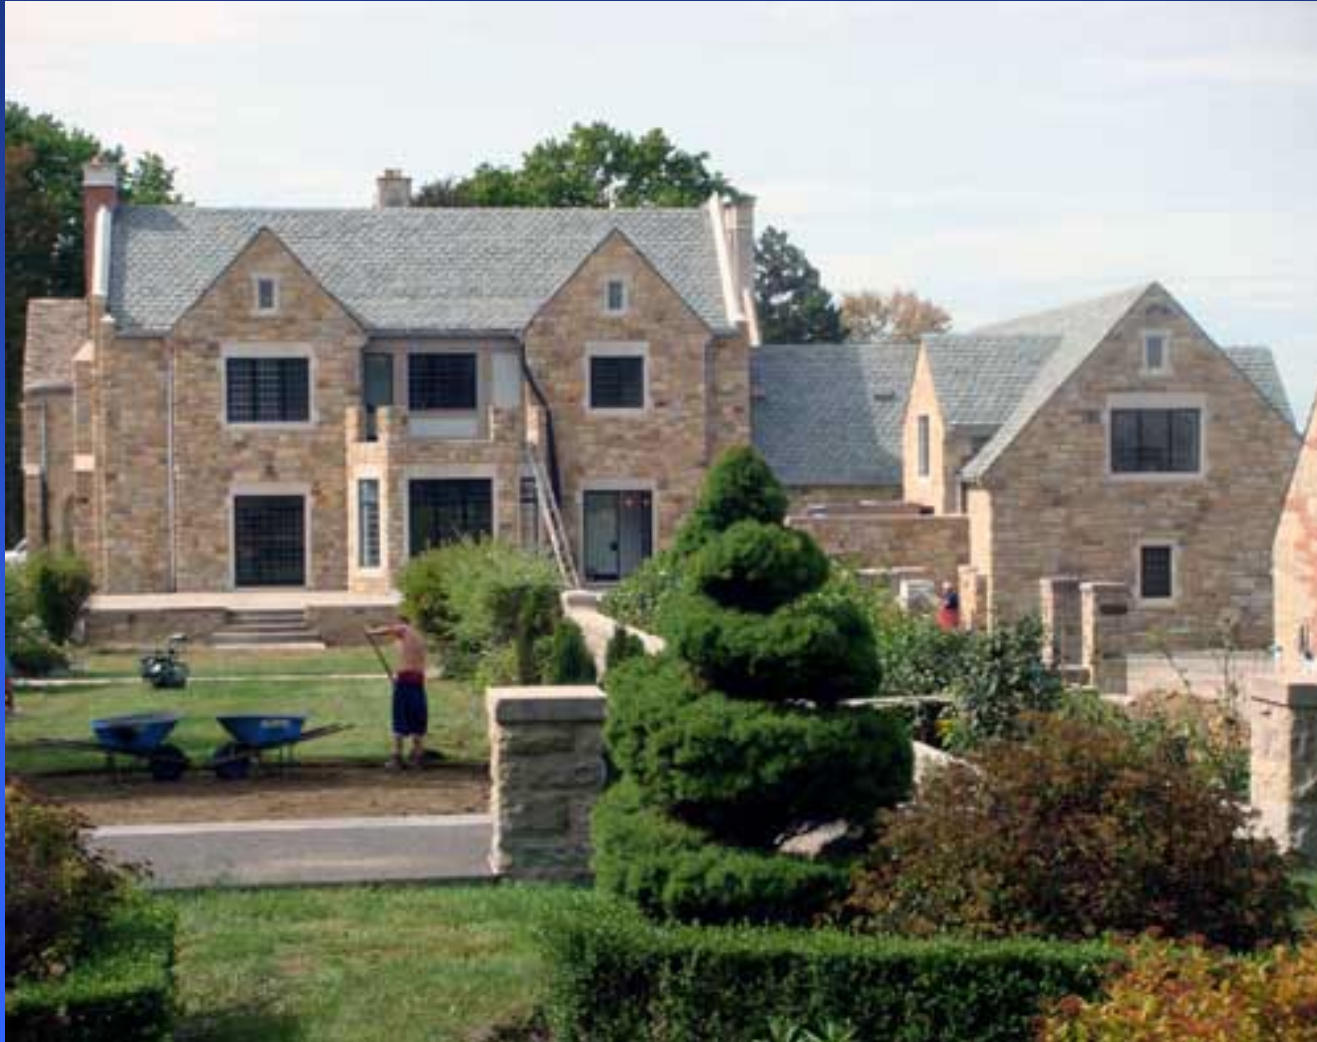
This is what that roof looked like. You cannot see the headlap deficiency without close inspection.

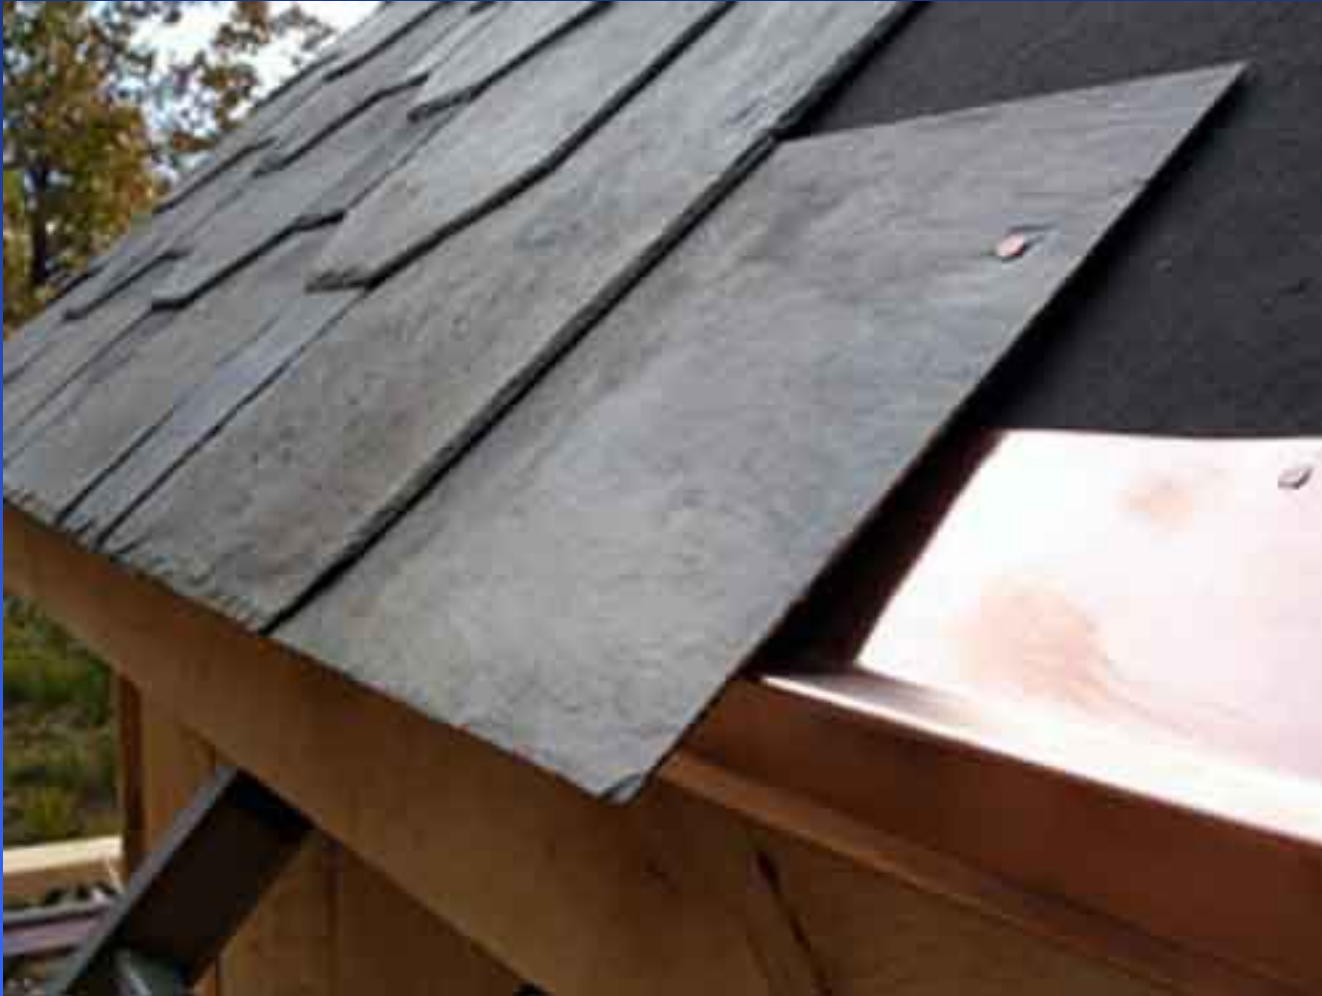
Correctly installed starter with copper cant:

Cants for the starter course can be a wood strip or can be built into a metal drip edge. The cant tilts the starter course to match the field slates.

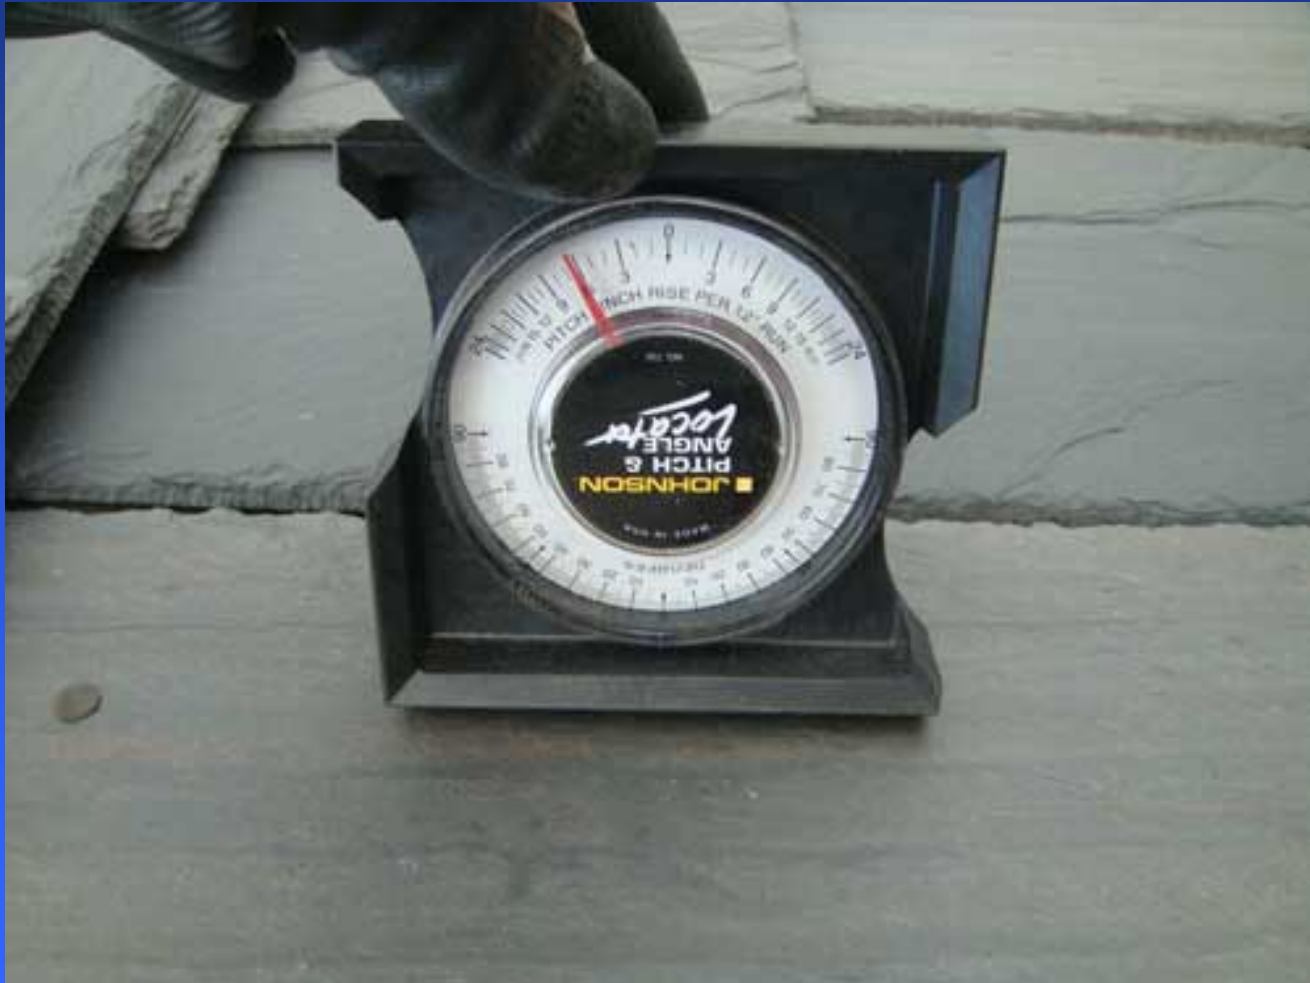
An angle locator is helpful. It's necessary to know what the slopes are in order to determine the correct headlap.

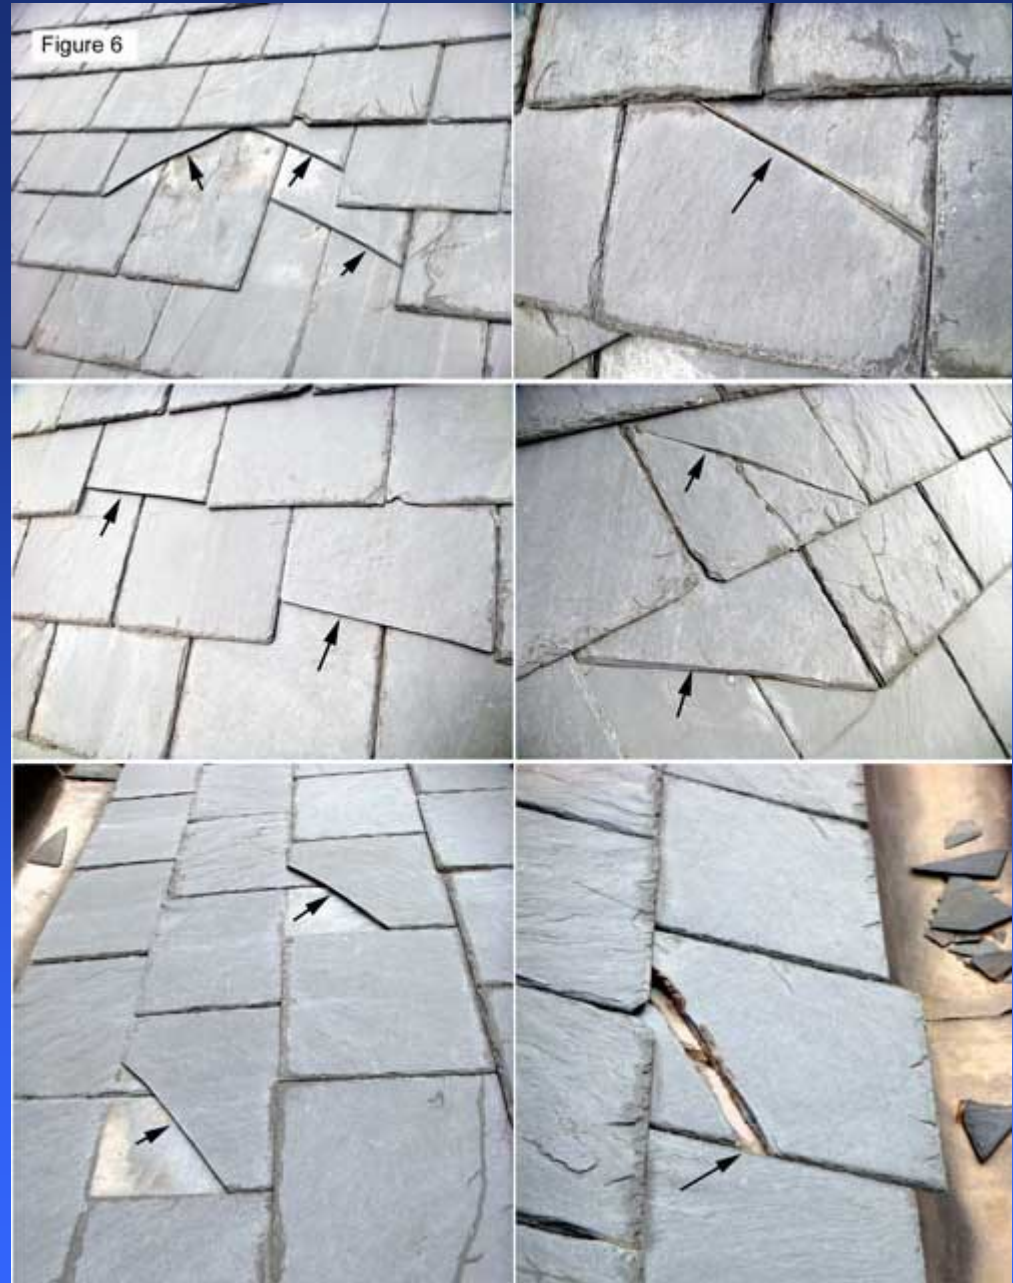
Most of the fractures shown here are defects in the original Spanish slate rock. This is unusual.

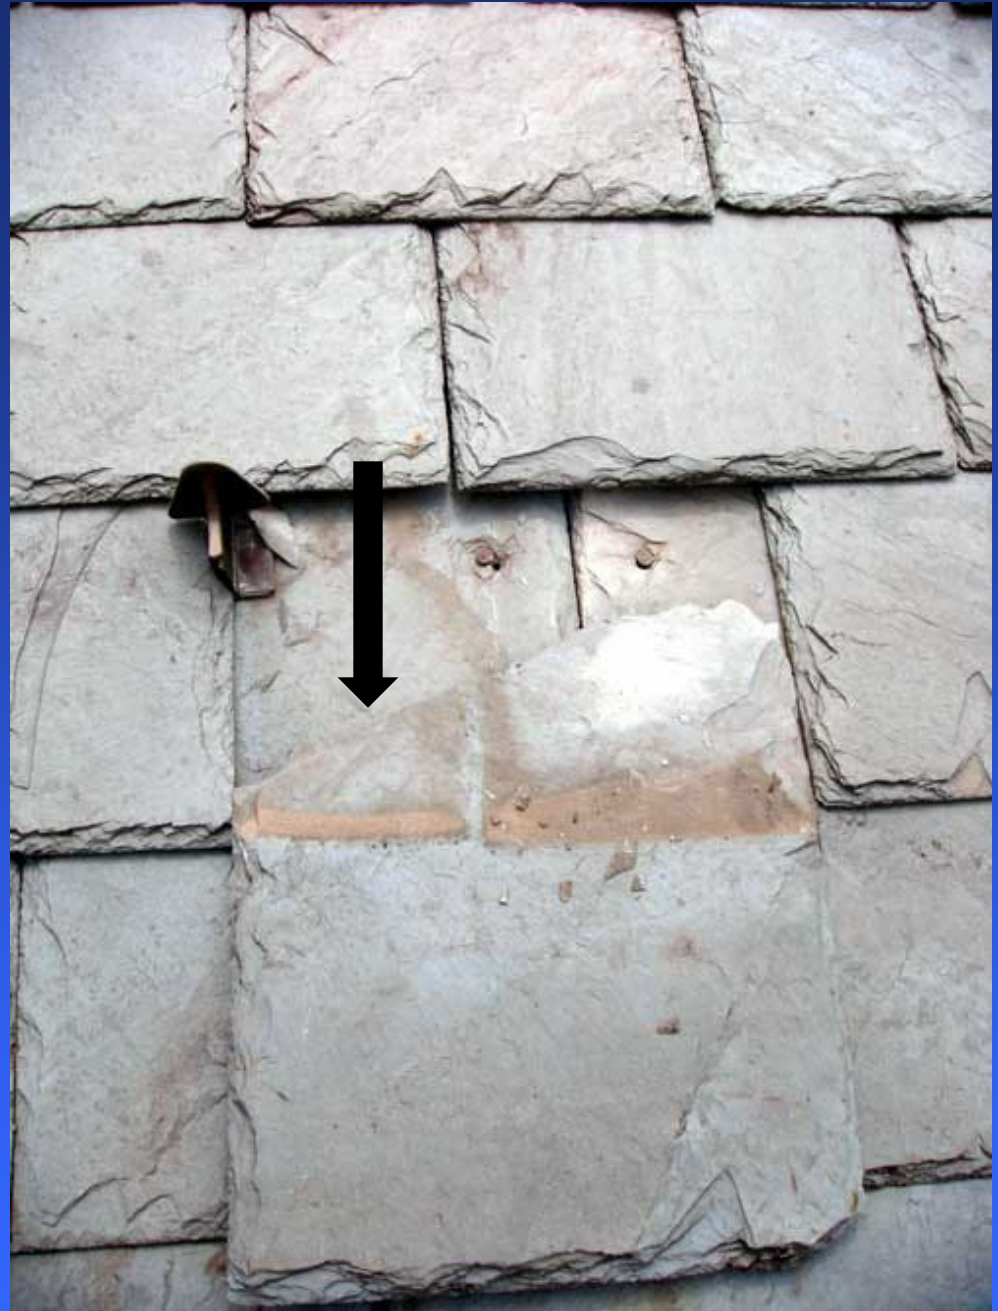
Probable foot-
traffic damage
(the bottom half
of the slate is
broken off):

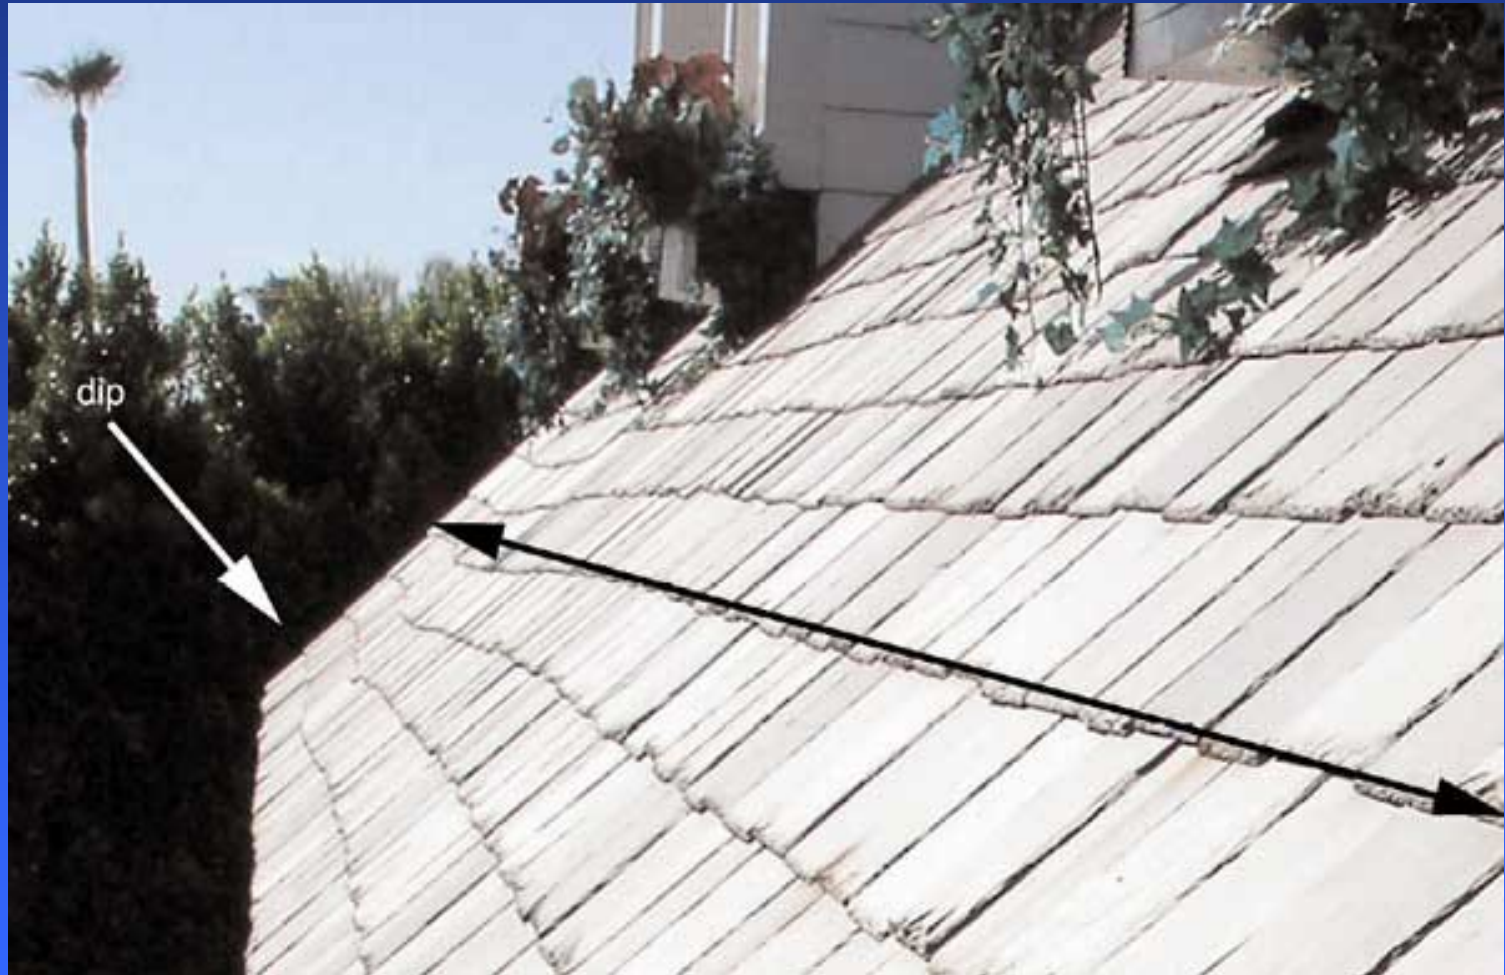
A poor layout will have headlap issues. This installation was condemned, and the roof had to be replaced in its entirety.

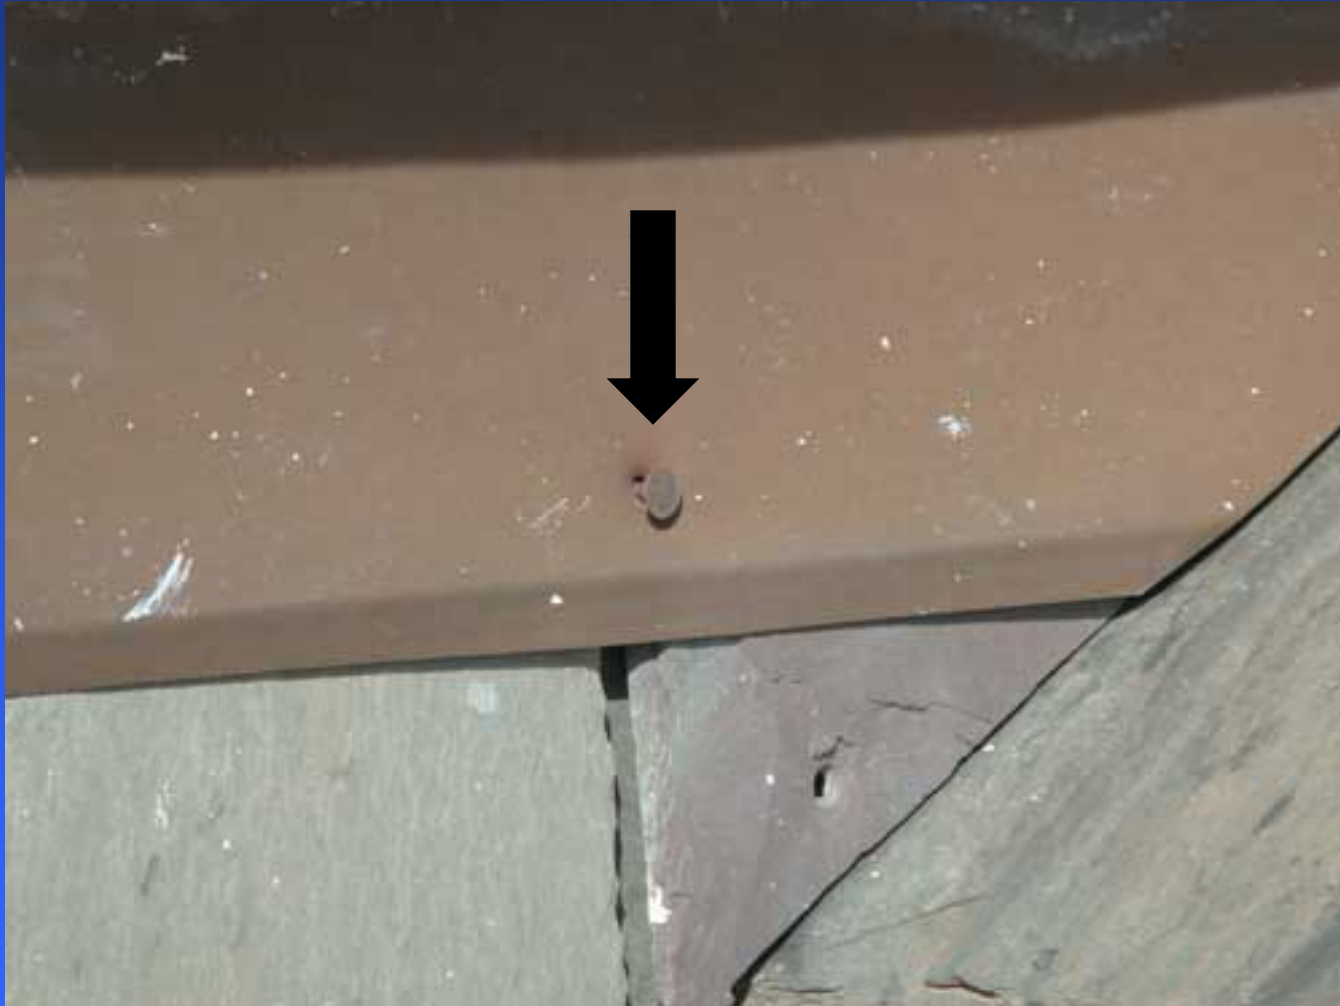
Any loose nail will create a leak:
