28th RCI International Convention and Trade Show

How to Survey a Slate Roof

Joseph Jenkins

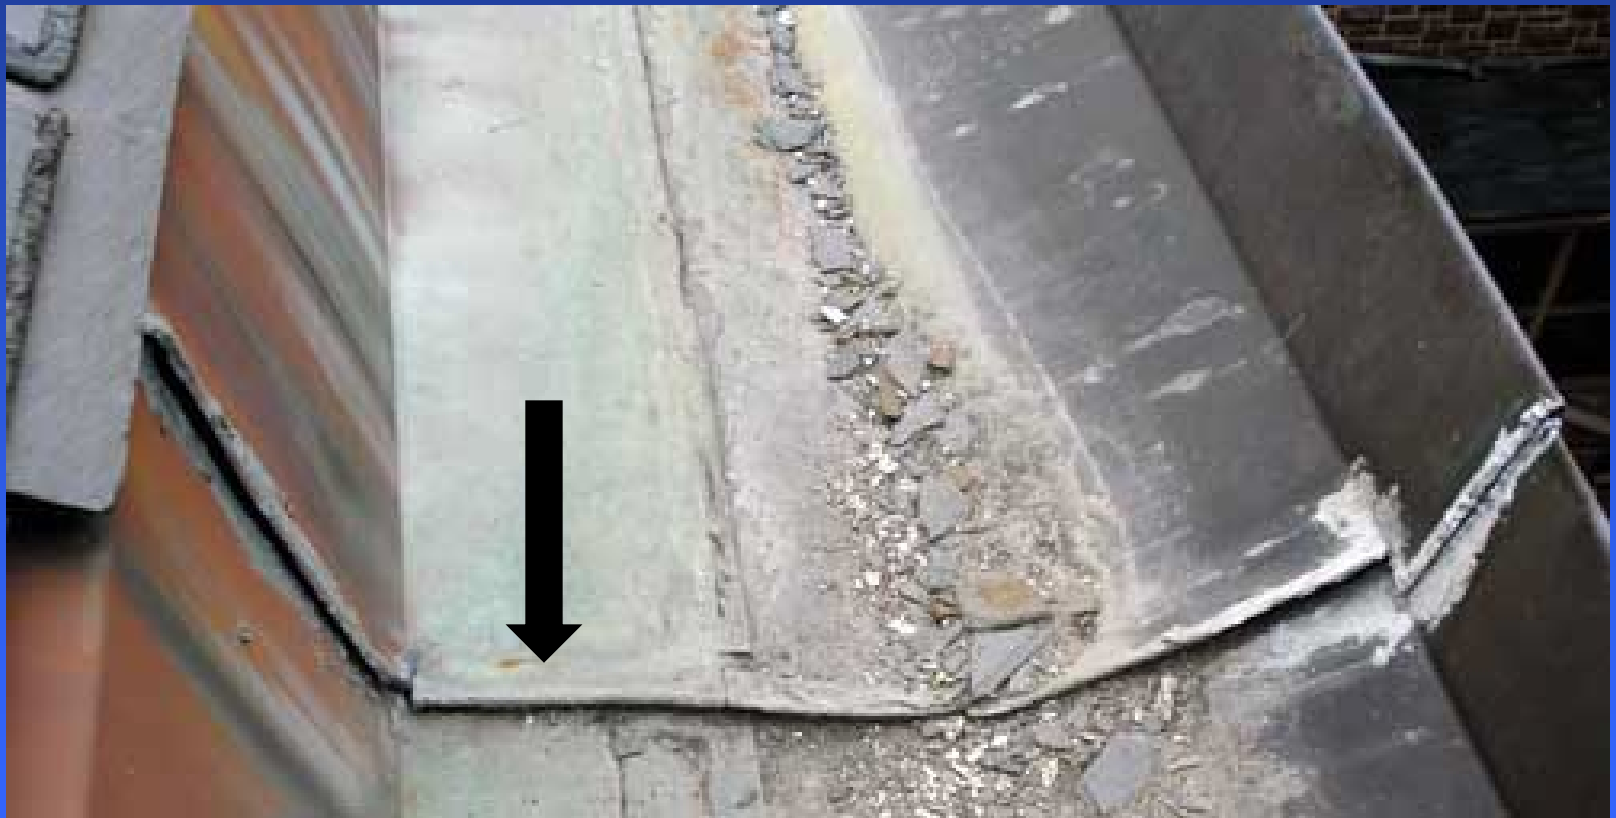
Built-in gutters often have problems at the solder joints, due to thermal expansion.

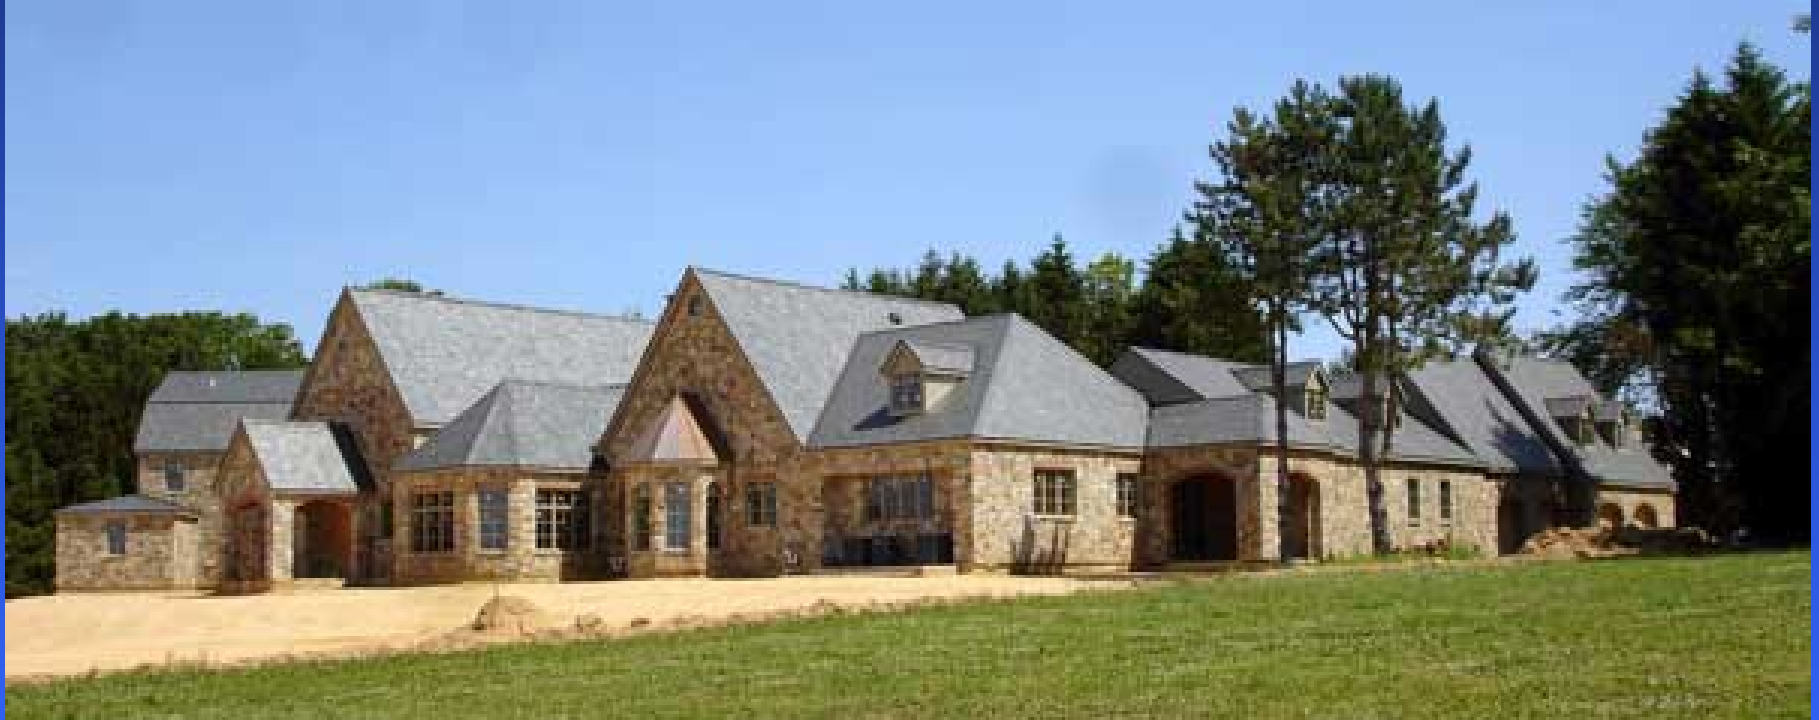
New roof, Indian slate, had to be completely removed and reslated.

Bad flashings, bad headlap, bad sidelaps, numerous installation errors.
