# SLATE ROOFS

by Joseph Jenkins

Not many people know a whole lot about slate roofs, but there is one group that has a reputation for being particularly inaccurate in their knowledge. When a property owner reveals that a “home inspector” has passed judgement on their slate roof, professional slaters can be pretty sure the assessment is incorrect and probably way off base. This article aims to help fix that problem.

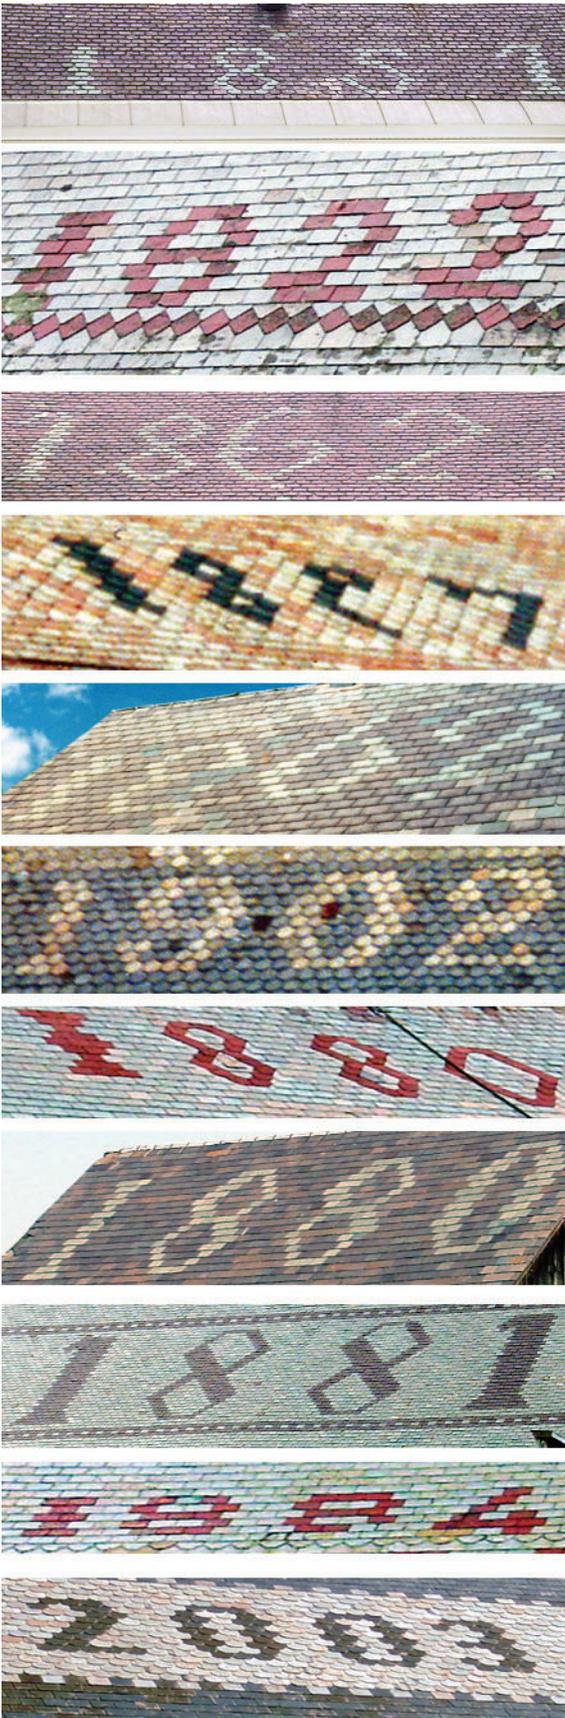
Figure 1: Dates inscribed on existing house and barn slate roofs. All photos by author except 1822 roof, which was taken by Steve Taran Jr.

A slate roof is a very specialized roofing system that dates back hundreds of years. Many existing slate roofs in the United States are over a century old and still in use. All but one of the photos of the dates written into slate roofs shown in Figure 1 were taken by the author (the 2003 date was installed by the author). These are roofs that are still functioning well, some even after 150 years or more.

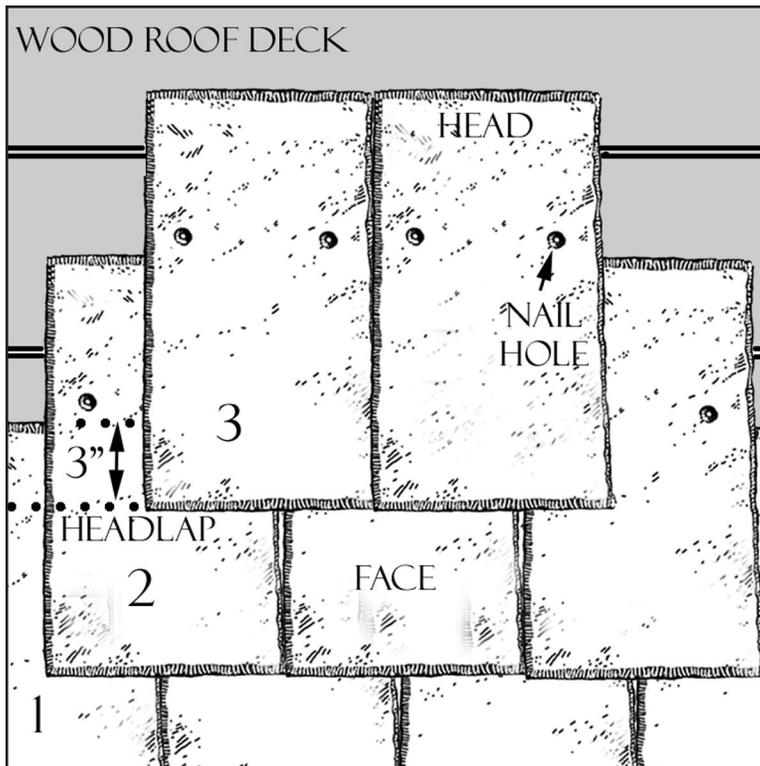
Figure 2: Standard slate installation pattern, showing overlap, headlap, placement of nail holes, "face" and "head" of the slate. Course #3 overlaps course #1 by three inches. This is called the "headlap."

In a standard slating pattern, each slate is the same length and width (although shapes may vary). Each slate is fastened to the roof along a chalk line that marks the top edge of the slate course with two nails. It is very important to understand that each slate overlaps *two* courses below it. This is called the “headlap” because the top of the slate, or the “head,” is being overlapped by the slates two courses above (see Figure 2). This headlap is usually three inches, but can range from 2” to 4” depending on roof slope or other factors. The headlap is one element of a slate roof that is critically important, because without it the roof would leak like a sieve. Slate sizes, widths, lengths, colors, shapes, and thicknesses can all vary, but a proper headlap must be maintained. A minimum three-inch headlap is standard, but greater headlap is acceptable. Less headlap can

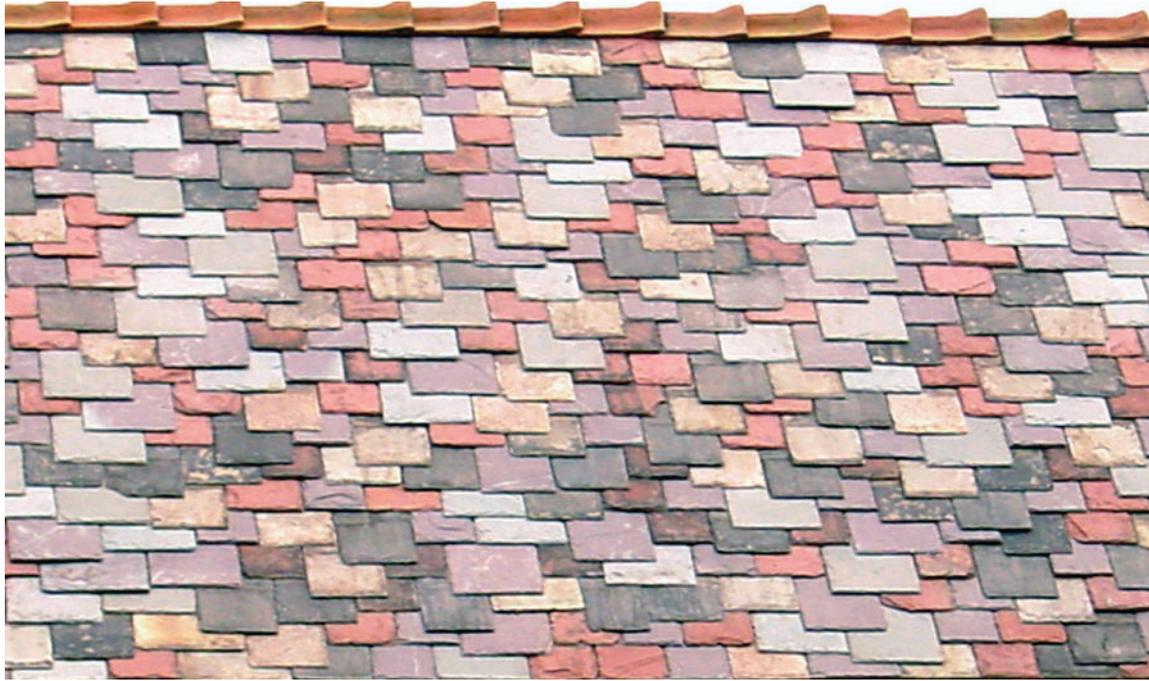
Figure 3: This new slate roof, installed by the author, shows a variety of slate types, including salvaged New York red, Vermont unfading green (the lightest ones), new Vermont sea green (the medium gray ones), salvaged Vermont sea green (the tan ones), Vermont unfading purple (solid purple) and mottled green and purple (purple with green spots, flecks or streaks), Virginia black (the dark gray ones), and Vermont salvaged, polluted sea green slate (the dark ones with the light spots, darkened by air pollution over a century).

Figure 3 shows a new slate roof installed by the author and made with a variety of new and salvaged slates, clearly illustrating the striking contrasts in color and shade between common types of roofing slate. What you can't see is the longevity of each type of slate. Half of the slates on that roof are already 100 years old. The other half are brand new. It is very likely that this roof will last a century — well into 2100.

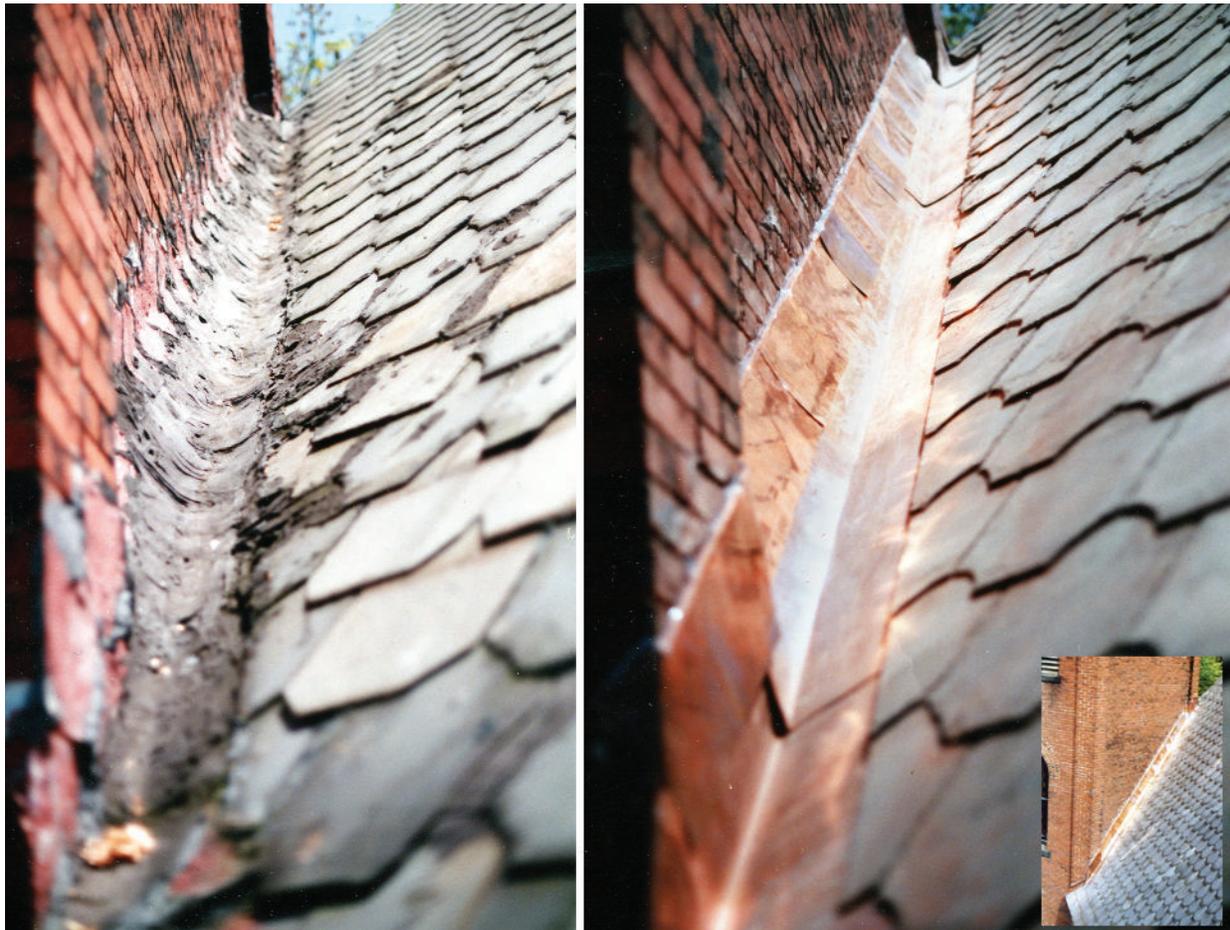
Figure 4: This bell tower on a church built in the late 1800s displays the typical deteriorated flashing and poor maintenance common on slate roofs in the United States today. However, one slater with a helper removed the tarred mess and replaced it with new copper and matching slates in a single work day. Such revitalization of old slate roofs is routine work for experienced slate roofing professionals.

Figure 4, left photo, shows a bell tower on a church that has been poorly repaired with roof cement, unfortunately a common sight on old slate roofs. The photo on the right shows how a mess like that can be cleaned up and restored with new copper in one day by a professional slater and helper. Figure 5 illustrates a similar situation — valleys that were tarred repeatedly by Neanderthals until the roof looked beyond hope (and, of course, still leaked). However, one day's work by a professional slater working alone cleaned up the roof and gave it an almost miraculous new lease on life. Such is the art of slate roof restoration.

A layperson or a home inspector may look at either of the situations shown in these photos and be immediately convinced that the roof is shot and must be replaced. When a slate roof professional looks at the tarred mess, he sees a common sight that can be routinely repaired. Remember, any part of a slate roof can be removed and replaced. If a section of a roof has been severely damaged by Cro-Magnon Man, it can be repaired, or as a last resort, selectively removed and reslated. Box gutter linings, or “built-in” gutters, are another common problem on old slate roofs because the metal deteriorates and leaks. They, like valleys and any other flashings on any slate roof, can be replaced without removing and replacing the entire roof.

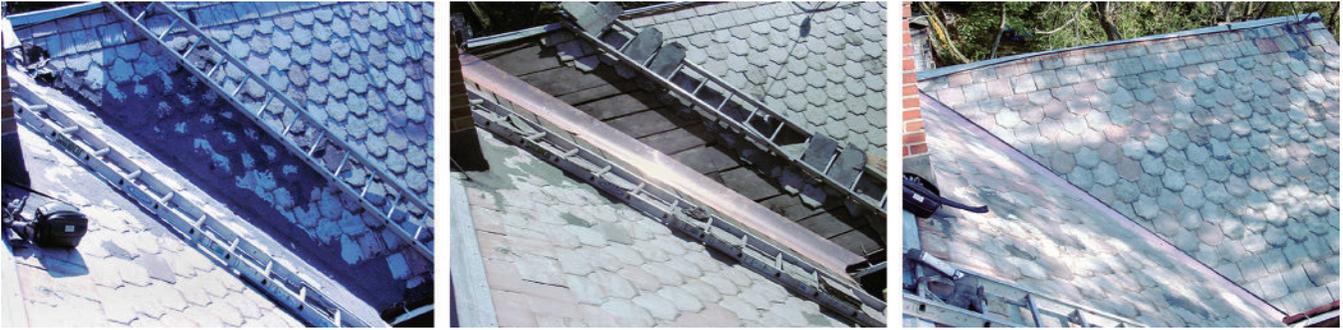
Figure 5: A valley on a late 1800s residence has been repeatedly tarred, walked on, and abused by the Cro-Magnon Roofing Company (left). However, it is restored by a professional slater, working alone, in one work day. The old valley and all tarred slates are removed and new 20 ounce copper valley flashing is installed (center photo). The valley is then reslated with matching salvaged Vermont “sea green” slates (right photo). When the job is done, the house roof is almost as good as new, but untrained eyes would likely have condemned this roof at first sight.

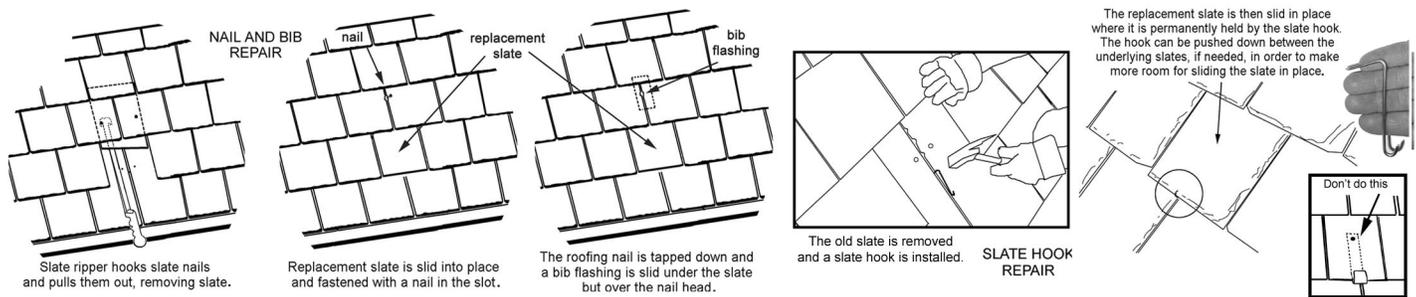
Figure 6: Individual slates can easily be removed and replaced on a slate roof. A “slate ripper” is used to remove the broken slate by pulling out (not cutting) the nails that hold the slate. A matching replacement slate is slid into place, then fastened in one of two ways: with a nail in the overlying slot covered by a “bib flashing,” or with a slate hook. Exposed strap hangers should be avoided because they are unsightly and will open up under pressure of snow sliding off a roof.

Faulty slates should simply be removed and replaced. Replacement slates matching in size, shape, and color must be used whenever possible. Replacement slates must never be fastened in place with visible straps or exposed nails (known as “face-nails”). Instead, there are two generally accepted methods of fastening replacement slates into place: the *nail and bib method*, or the *slate hook* (see Figure 6).

The nail and bib method is perhaps the most widely used. This involves removing the broken slate with a slate ripper, then nailing the replacement slate with a nail in the slot between the overlying slates and then sliding a “bib” flashing under the overlying slates and over the nail head. The bib is often bent slightly in order to fit into place by friction. It can be composed of aluminum, copper, or other non-corrodible metal, but it should not be shiny and reflective like stainless steel as it may then be visible from the ground on a sunny day. Instead, copper or brown painted aluminum (coilstock) blend nicely into the roof and are preferred. A

A slate hook is a hard wire hook made of galvanized steel, copper, or stainless steel, approximately three inches long. A small exposed loop hooks the replacement slate in place. This is one instance when an exposed repair device is acceptable because the tiny hook is almost invisible from the ground. Stainless steel hooks are stronger than copper hooks. Slate hooks are preferable to the nail and bib on new slate roofs, especially for repairs in the field of the roof. Exposed strap hangers used for repairs are to be avoided because they’re unsightly and they deface the roof.

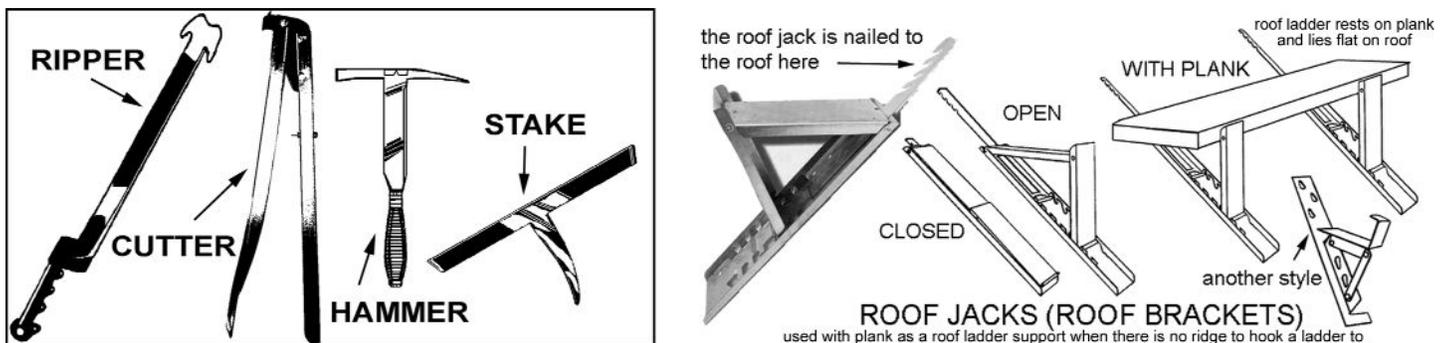
Figure 7: Basic tools of the trade include the slate ripper, for pulling out old slates; the slate cutter, for cutting and trimming slates; the slate hammer, for punching holes in slates (some styles also cut slate); and the slater’s stake, used as a backing when cutting slates with a slate hammer. Roof jacks, also called roof brackets, provide a quick, relatively safe way to access a slate roof when there is no ridge for hooking a ladder. The roof jacks are nailed in the slot between the slates and when removed, a bib flashing is slid in the slot to cover the nail holes. Alternatively, a slate can be pulled out in order to allow a roof jack to be nailed to the roof without penetrating any slates.

The tool required for removing slates from a roof is the *slate ripper* — a sword-like object that slides up under the slate and yanks out the two nails that hold it in place. It does not *cut* the nails — it pulls them out, bending them in the process. You never not want to cut the nail because that will leave a piece of nail under the slate which will interfere with sliding the replacement slate into place.

A *slate hammer*, another important slate roofing tool, has a hole punch at one end used to punch nail holes in slates. Some slate hammers also have shanks designed to cut slates, which is done by a chopping motion against a straight edge, typically a *slater’s stake*. Salvaged slates readily punch without breaking, leaving a clean hole with a "countersunk" characteristic into which the nail head sits. New slates can be hard and brittle and require some practice for easy punching with a slate hammer. Standard thickness slates (3/16” to 1/4”) are readily cut with a simple hand-held device, a *slate cutter* (see Figure 7).

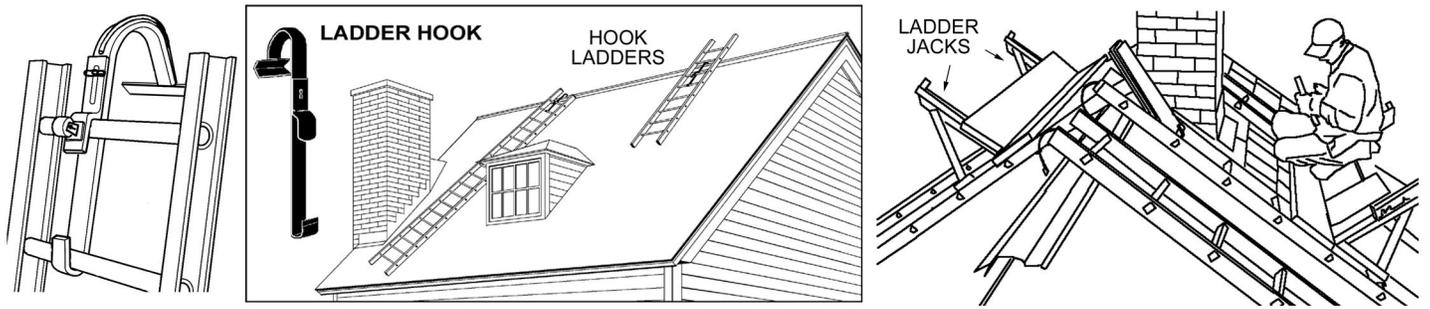
Figure 8: Professional slaters do not routinely walk on slate roofs because foot traffic on slate roof damages the slates. Instead, if there is a ridge to hook onto, hook ladders are used. Hook ladders allow safe access to slate roofs without breakage of the slates. “Ladder jacks” can quickly attach to hook ladders to create a safe work platform or roof scaffold by providing a framework to support wooden planks. Professional slaters may use a combination of hook ladders, ladder jacks and “roof jacks” (Figure 7) when accessing slate roofs.

Experienced slaters work on slate roofs using *hook ladders*, which keep their weight off the slate while giving them a safe work platform to cling to. It is not proper to work on slate roofs by walking on them using ropes, as walking on slate roofs breaks the slates; this is the primary reason why low-slope slate roofs fail prematurely. Murphy’s Law of slate roofing states: “If it *can* be walked on, it *will* be walked on,” so the best slate roofs are those that are too steep to walk on. Slate roofs *can*, in some circumstances, be carefully walked on by a qualified slate roofer, and that means a slater who will repair any slates he may break during his moving about, which is usually done carefully and on all fours.

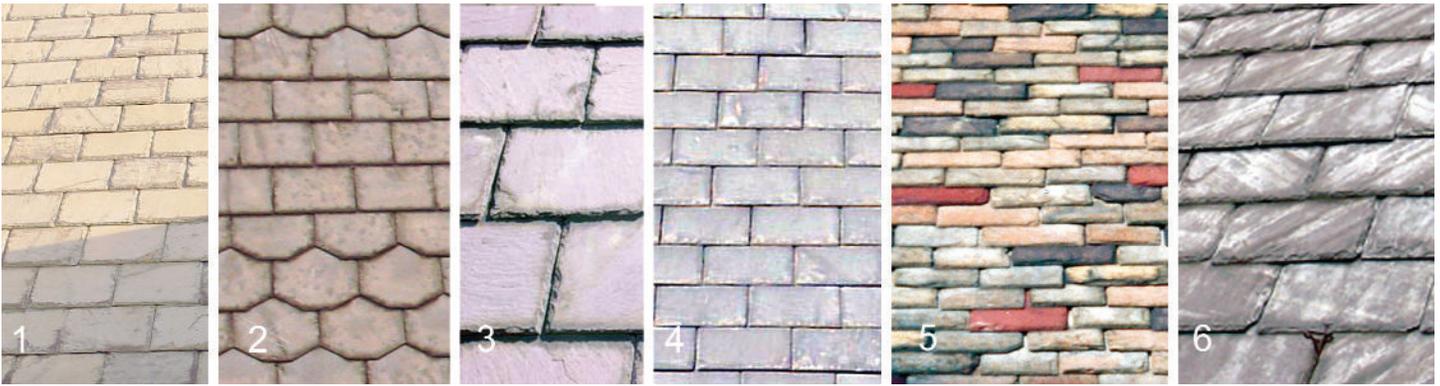
Figure 9: All slate is not the same. The above sampling of slate roofs includes, 1) a 70-year-old Vermont unfading green slate; 2) 110-year-old Pennsylvania black slate (a harder variety); 3) 90-year-old Vermont purple slate; 4) 100-year-old Buckingham, Virginia slate; 5) a mix of sea green slate (also known as semi-weathering green), Buckingham, and NY red slate; 6) Chapman (PA) slate with its characteristic diagonal striations. To see more examples of slate roofs, or to help determine their expected longevities, go to [slateroofcentral.com](http://slateroofcentral.com) and click on “how to identify your roof.”

1) Identify the slate (see Figure 9). You can’t do this with binoculars on a rainy day. Wet slate does not look the same as dry slate. The single most important detail of a slate roof inspection is the *type of slate*. Until you determine the type of slate, you can’t do much else. Find out how old it is while you’re at it. Most slate roofs were installed when the building was erected. In any case, if the slate is still good, the roof is repairable. There is a “how to identify your slate” page at [slateroofcentral.com](http://slateroofcentral.com).

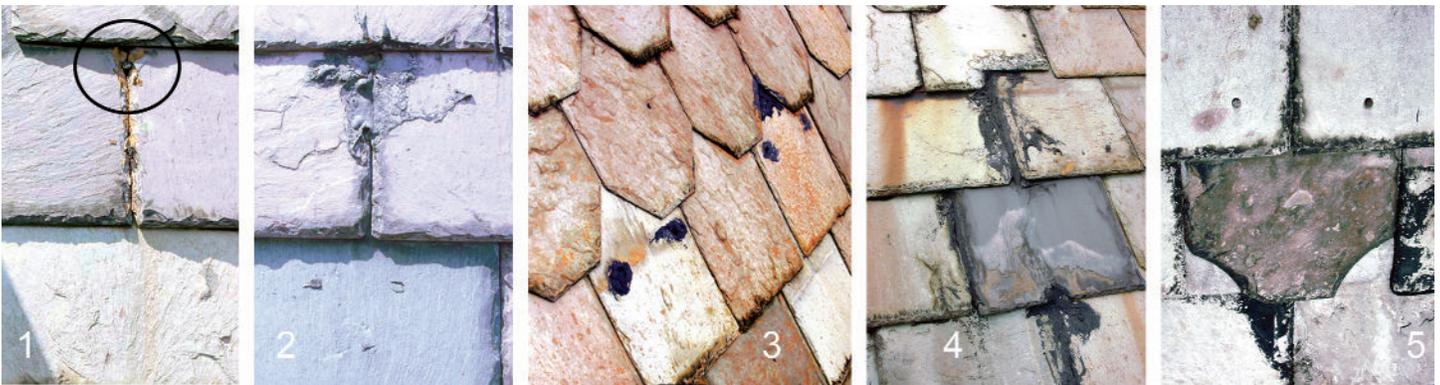
Figure 10: Bad repairs can be found on almost any old slate roof. Some constitute “hidden leaks,” such as #1 above, where a nail has been driven into the top of the slot, caulked, then the caulk has worn off leaving an almost invisible hole in the roof. A bib flashing would have prevented this problem and will still solve the problem if inserted at this time. #2 illustrates the same problem, this time with roof cement rather than caulk. #3 shows “face nails” that have been tarred over — these are guaranteed leaks. #4 illustrates two obvious errors: wrong type of replacement slate and exposed roof cement. #5 is another example of a multiple error — face nails, wrong type of slate and wrong shape of slate. All of the above can be removed and the roof properly repaired.

have it repaired correctly. Abused roofs include the ones that are walked on by “Bigfoot,” the ones that are face-nailed, tarred, repaired with non-matching slates, coated, or reflashed incorrectly (see Figure 10).

3) Look for any bad, old repairs. They will almost certainly be there. They will look like tar patches, metal patches, slates of the wrong color, shape, size or type, face nails, and exposed straps. These can all be erased and the roof put back in order, if the slate is still good.
