PROJECT SPOTLIGHT: GLENRIDGE HALL, SANDY SPRINGS, GA THE R.W. STOKES COMPANY

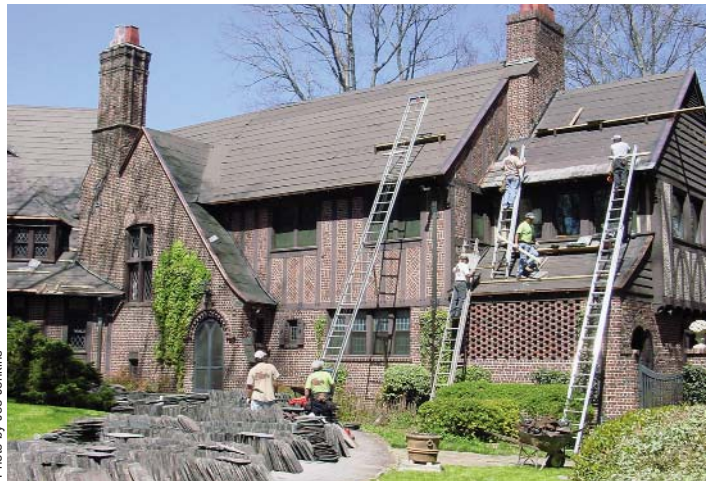
Glenridge Hall, front entrance, after the original slate had been removed and stacked in the driveway and the new felt installed. Re-slating is just beginning.

Ron Stokes' crew foreman for this project was Manuel Avila whose crew had to remove all of the slate on the entire Hall, salvage it as best they could, then re-install it back on the same building with proper headlap over half-lapped 30 pound felt. The salvaged slates were used on the front of the Hall first, in order to preserve the historical look of the building. The front, however, consumed just about all of the salvaged slates.

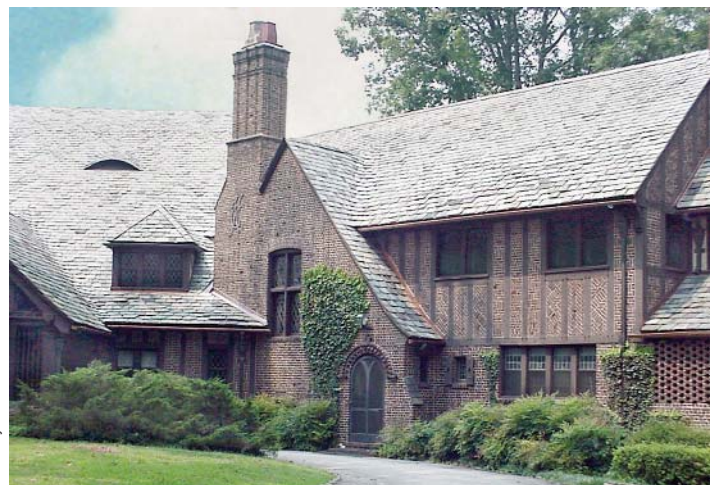
Glenridge Hall. The finished roof is not only beautiful, but also historically accurate. It can realistically last another century.

New slates of the same color mix and graduation scheme were installed on the back of the building, supplied by Steve Yoder of Classic Slate and Tile in Atlanta. The rounded valleys and eyebrow dormers were fortified by 20 ounce copper flashing applied underneath each course of slates in the curved sections. All of the remaining flashings on the roof were replaced during the re-installation, again using 20 ounce copper. This was a long, arduous project delayed by a lot of rainy weather, but The R.W. Stokes Company managed to complete it in the summer of 2003.
