# SLATE ROOFS

## AVOID THESE 21 CONTRACTOR ERRORS

Joseph Jenkins

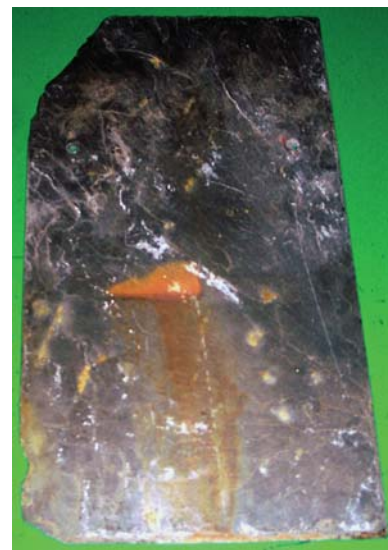
Figure 2: This Spanish black slate leached rust stains down the new slate roof after only one year.

Some Spanish black slates are known for their pyrite content, which will bleed red rust stains down the roof. Figure 2 shows such a slate taken off a residence in Florida after only one year on the roof. This large residential roof had to be completely reslated, again at great expense. The owner of the residence selected this slate because he liked the shade of black, not understanding that some slates can change in appearance with exposure to weather. When selecting Spanish slates, it is important to know whether those being considered are pyrite-bearing, a condition that may or may not be obvious by visual inspection. In a recent case on the east coast, an entire church roof had to be reslated because the new Spanish black slates were bleeding rust down the roof and the church people did not like the way it looked. Again, this is not to be construed as a condemnation of all Spanish black slates, as some are quite good.

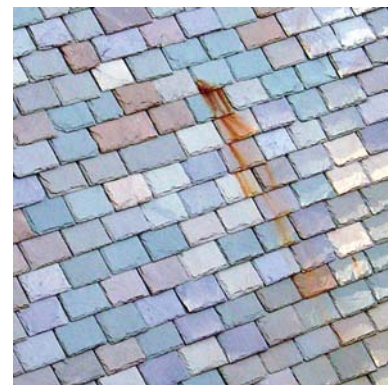
Figure 3: Even domestic slates can rust. These Vermont slates on a high-rise apartment were poor in quality and should have been screened for pyrite inclusions.

**4) CULL OUT BAD SLATES:** Poor quality slates can originate from any quarry. This may be due to the manufacturer not culling out rejects, for example. Shoddy quality control can lead to rusting pyrites on even the best American slates. Figure 3 shows Vermont slates badly rusting down an apartment building roof. This is unusual and indicates a commercial source of roofing slate that should have been avoided, or a bargain slate that wasn't worth the money, and/or a contractor who should have culled the defective slates out, but didn't know what a bad slate looked like.

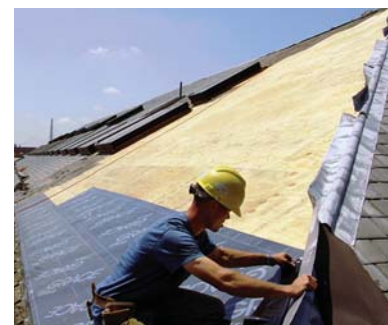
Figure 4: Traditional slate roofing systems, despite their incredibly successful performance, are being largely abandoned in favor of plywood roofs with peel and stick underlayment.

Figure 4 shows a 150-year-old slate roof being replaced in Boston. Although the roof was still functioning at the time of replacement, and the existing roof system, made of slate, 1" boards, 30 lb. felt, and nails, had demonstrated a 150 year performance, the contractors who replaced the roof completely abandoned the existing system and replaced it with one that had no proven longevity, emphasizing underlayment and completely eliminating any chance of air transpiration. The original 1" roof board deck, still sound, was covered with 1/2" plywood, then peel and stick, then 30 lb. felt, then slate. Will this new roof system last 150 years? Time will tell, but why reinvent the wheel? A chain is only as strong as its weakest link. Traditional slate roofing systems have already proven themselves, are less expensive, are more environmentally friendly, and take less time to install. If one wants to guarantee that a slate roof will last a century or two, traditional methodologies should be followed.

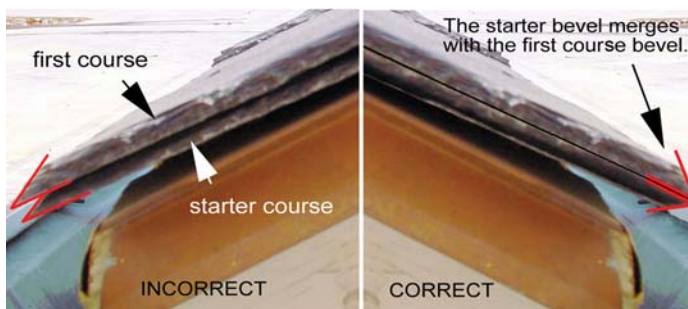
Figure 5 (right): The starter course should be flipped over and laid upside-down as shown on the right in this illustration. This creates a clean drip edge and allows for correct nail counter-sinking.

first course of slate. The starter course slate should be installed face down, unlike all the other slates on the roof, which are installed face-up. This is the traditional installation method as it allows for a clean drip edge where the starter slate meets the first course (Figure 5). Inexperienced installers often put the starter course face-up.

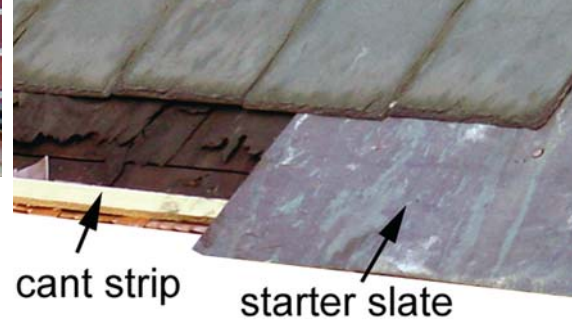
Figure 7 (above): Note that the starter slate is laid back-side-up and is propped up by a cant strip.

Often, the cant or shim strip is missing underneath the starter course. Starter slates must be angled on the roof in order to match the angle of all the other slates in the field of the roof (Figure 6). Typically, this was done by installing a wood strip (Figure 7), but it can also be achieved by using a metal drip edge with a cant formed into the metal, or even by raising the fascia.

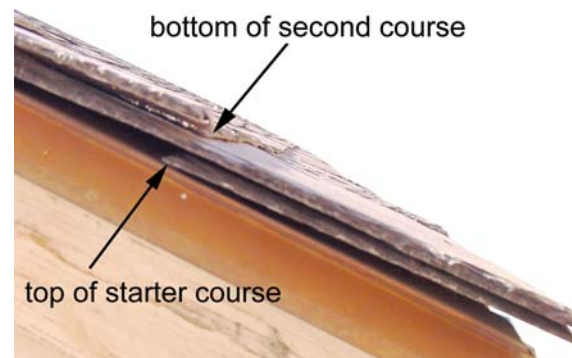
Figure 8 (above): The starter course should be overlapped by the second course by at least three inches. In this case, it is not overlapped at all. This is a serious, but common mistake. Note also that the starter slate is incorrectly laid back-side-down. This is an indication that the installer was inexperienced in laying slate.

Another common mistake on starter courses is a lack of headlap, especially when the field slates are turned sideways and used for starter slates. An example of a starter course lacking headlap is shown in Figure 8. Read more about starter courses in TR 5 ([traditionalroofing.com](http://traditionalroofing.com)).

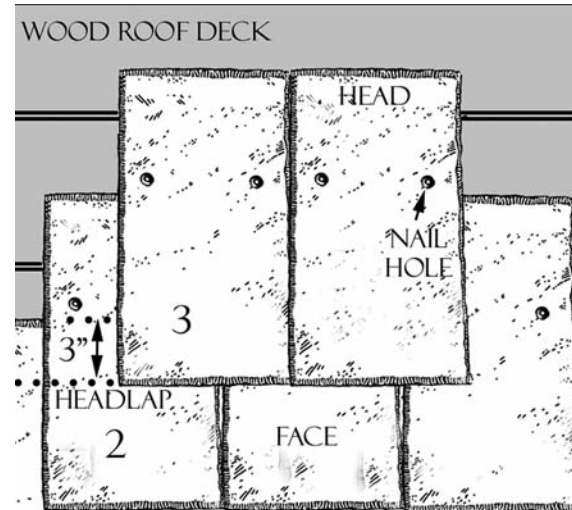
Figure 9 (above): Headlap is a critical detail on a slate roof. Lack of headlap will cause an entire roof to be condemned. Read more about headlap in TR6.

**8) GET THE HEADLAP RIGHT:** If the headlap is missing or inadequate, the roof is probably going to be condemned. Headlap is the overlap on each course of slate by the second course above it (Figure 9). This overlap is what prevents the roof from leaking. Three inches is standard, but headlap can vary according to the slope of the roof. Figure 10 shows a shopping center roof in Louisiana, newly installed, with about an inch of headlap on the field slates. The overlap should be 3". There is no fix for this inadequacy other than to rip off the entire roof and start over.

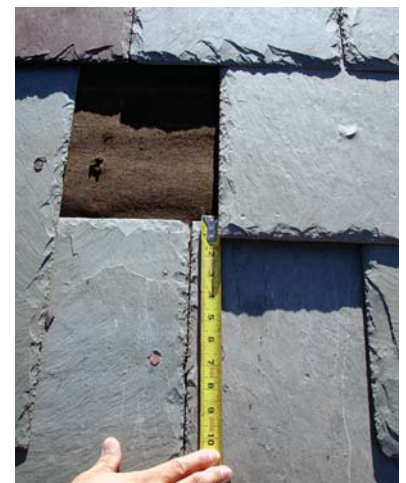
Figure 10 (right): This is an example of inadequate headlap (about 1") on a shopping center in Louisiana. There is no solution for this poorly installed new slate roof other than to remove it and start over.

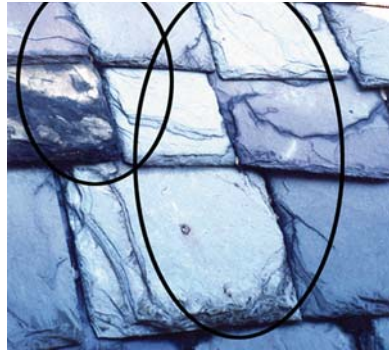
Figure 12 (above): "Sidelap," or lateral overlap, should be 3" minimum. Here we see no lateral overlap at all. This roof had to be removed and reslated as it also had no headlap.

**9) WATCH YOUR LATERAL OVERLAPS:** Lateral overlaps, or sidelaps, should also be 3" minimum. However, don't be surprised to see slates with no lateral overlap at all, as shown on an historic building in Georgia (Figure 12). Incorrectly placed sidelaps can leave the butt-joint directly over the slating nails, as shown on an historic Pennsylvania State Park building in Figure 13. This will allow direct water entry through the nail holes.

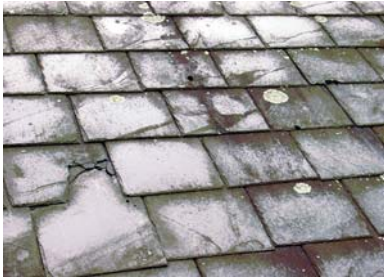
Figure 13 (above): Each course of slates should have been staggered so as to break the course below down the center. Instead, these slates were butted directly over the underlying slating nails, ensuring leakage.

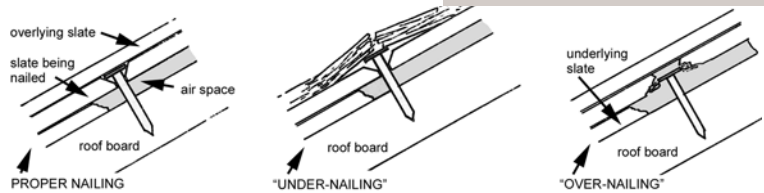
Figure 14 (above): A good slater has no problem nailing slates correctly. When properly nailed, the nail head just sits down inside the slate. When undernailed, the protruding nail head can damage the overlying slate over time. When overnailed, the slate being nailed will crack, break, or cock awkwardly on the roof.

**10) AVOID OVER-NAILING AND UNDER-NAILING:** Another common installation mistake is the overnailing and undernailing of the slates. Slate nail holes are meant to be crater-shaped to allow the nail head to sit down inside the slate (Figure 14). Otherwise, the nail head will protrude above the slate and rub against the overlying slate, eventually creating a hole (Figure 15). When the nail isn't driven far enough, this is known as undernailing. Overnailing, on the other hand, is when the nail is driven too far and breaks through the slate. This leaves the slate hanging on one nail or sliding out altogether (Figure 16).

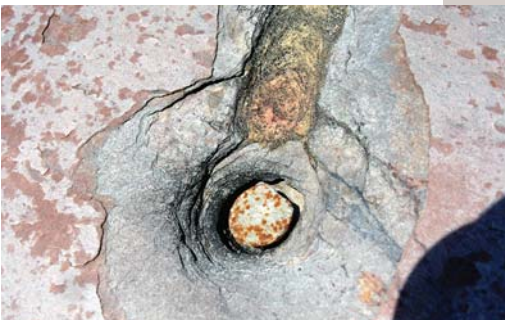
Figure 15: A protruding nail head eventually wears a hole in the overlying slate.

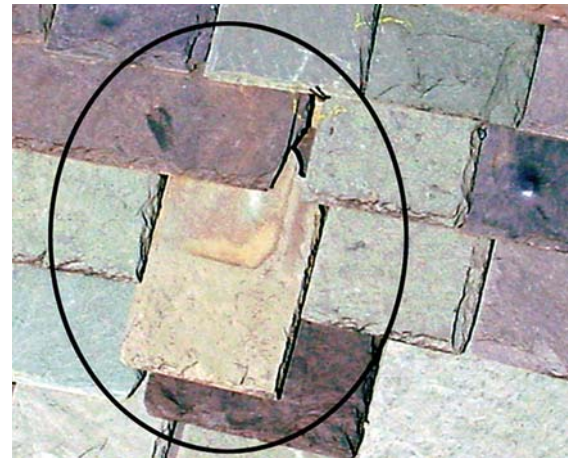
Figure 16: This slate was nailed so tightly that the nails broke through the slate and the slate is sliding out.

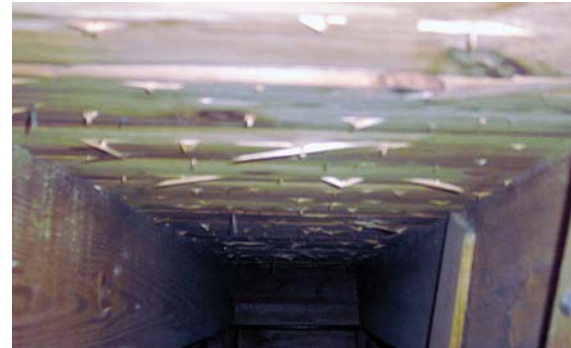
Figure 17: When the slating nails are too long, the back of the roof decking breaks out. This reduces the effective holding power of the nail. A longer nail, therefore, does not mean more holding power. The best nail length just barely penetrates the roof deck, if it penetrates at all.

**11) USE THE RIGHT NAIL LENGTH:** Nail length is an issue that is commonly off the radar screen of the average roofing contractor. The slating nails should barely penetrate the roof deck boards. If the nails are too long, they break through the back of the boards and splinter out the wood, reducing the board thickness where

the nail is located and undermining the effective holding power of the nail (Figure 17).

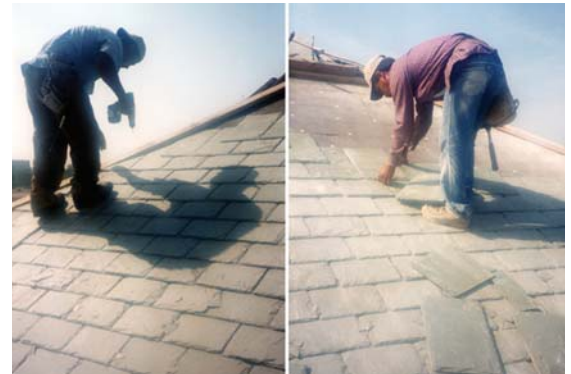
Figure 18: It is a mistake to walk on a slate roof during installation.

new slate roof installations is what I call the Bigfoot Syndrome — roofers walking on the slates during installation, as shown in Figure 18 on a new bank building in Kansas. An experienced slating crew will make every effort to keep off the slates during installation by staging the roof correctly (Figure 19). When Bigfoot walks all over the slates, the shingles

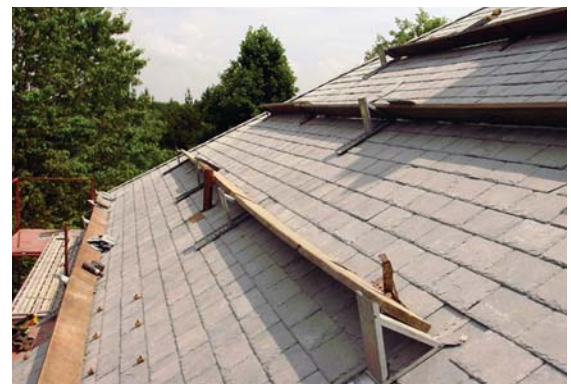
Figure 19: A correctly-staged slate roof will enable the roofers to install the slate without the need to walk on the shingles.

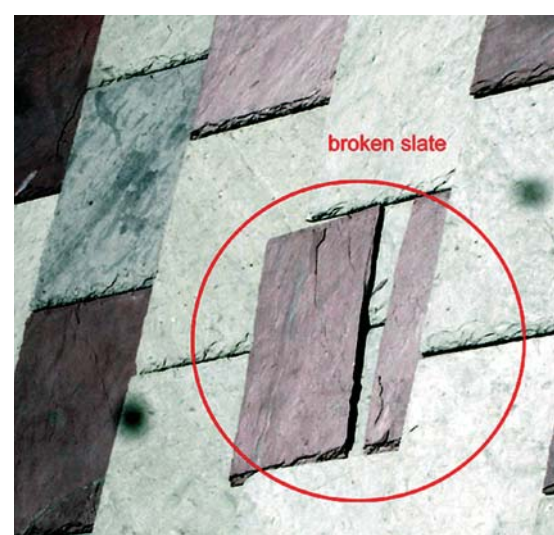
Figure 20 (above): Slate roofs that are walked on during installation will shed slates after the roof has been installed, perhaps for years.

crack and break (Figure 20). They may not fall apart immediately, but I have seen a hundred slates fall off a new slate roof within five years after installation due to the Bigfoot Syndrome.

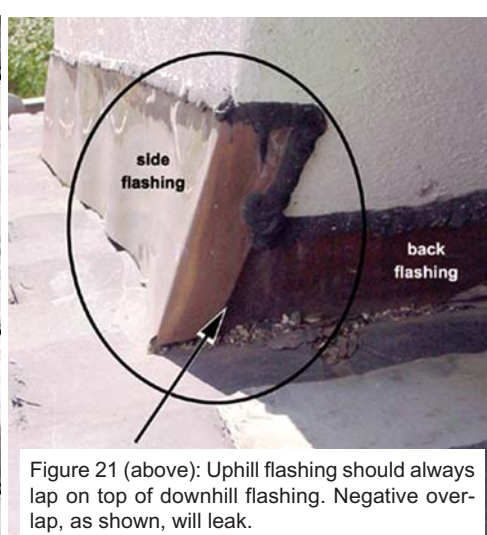
Figure 21 (above): Uphill flashing should always lap on top of downhill flashing. Negative overlap, as shown, will leak.

**13) INSTALL FLASHING CORRECTLY:** Flashings provide all sorts of opportunities for error. Negative overlap, for example, is sure to leak. Figure 21 provides an example of negative flashing overlap. Uphill flashing should always lap on top of downhill flashing. When lower flashings lap on top of higher flashings, water can enter the roof. Corner joints on roof penetrations are also commonly flashed incorrectly — chimneys provide a perfect example. The corner flashings must either be correctly folded, or else soldered in order to prevent leakage there. If a corner isn't folded or soldered, as shown in Figure 22, then the only thing keeping it from leaking would be caulk or sealant, which does not have adequate longevity. An incorrectly folded chimney corner is illustrated in Figure 23. This is a leak waiting to happen. Dormers also often have corners that need to be flashed. Without the knowledge of folding corners or soldering, a dormer corner can be left wide open and waiting for the first good rainstorm (Figure 24).

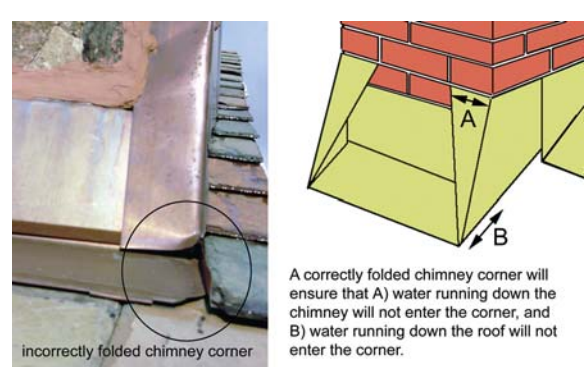
Figure 23 (above): This chimney corner flashing (left), although folded, was installed incorrectly and will surely leak. A properly folded corner flashing must account for the water that runs down the chimney as well as the water that runs down the roof. In effect, the flashing should create a mini-roof over each corner.

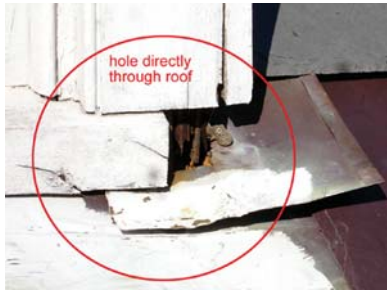
Figure 24 (above): This is a case where the corner flashing is neither folded nor soldered, leaving a large hole in the roof.

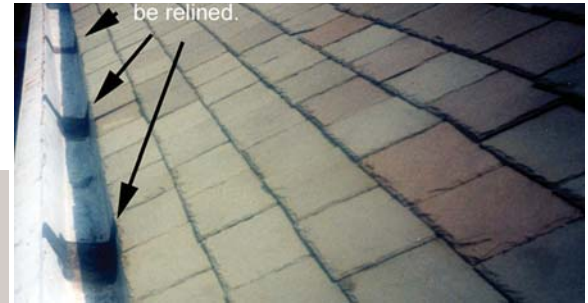
Figure 25 (above): Box gutters require expansion joints, otherwise the solder joints will crack under pressure. This is evident by solder joints that have been covered by roof cement, a common sight on box gutters, new and old.

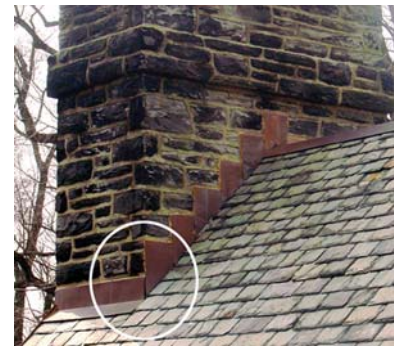
Figure 22 (above): Chimney corners flashings should either be folded or soldered. If neither is evident, then the corner is either sealed with sealant, or with nothing. In either case, this is a leak waiting to happen.

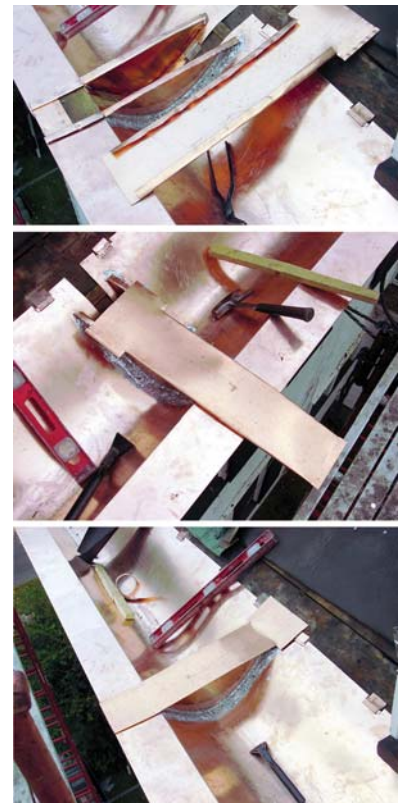
Figure 26 (above): Expansion joints allow built-in-gutters to move when expanding and contracting, thereby relieving the stress on the solder joints and prolonging the life of the gutter.

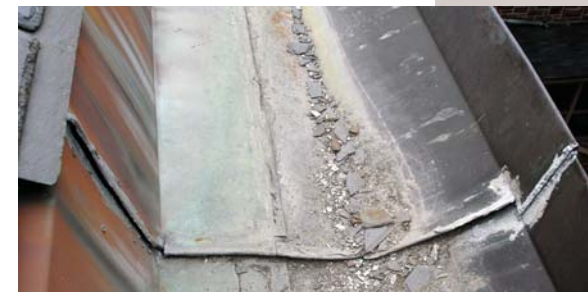
Figure 27: This is a perfect example of a new built-in gutter showing failed solder joints because not a single expansion joint was installed in the gutter system.

**14) ALLOW FOR METAL EXPANSION:** Common on many slate roofs are built-in gutter systems. "Box gutters" require expansion joints, but they're often installed without any allowance for expansion whatsoever. This becomes evident by the failure of the solder joints (Figure 27), which are often roof-cemented after they start leaking in order to alleviate water penetration (Figure 25). Expansion joints (Figure 26) can be added after the gutters are installed, but it's a lot easier to install them correctly in the first place. Read more about expansion joints in TR 6 ([traditionalroofing.com](http://traditionalroofing.com)).

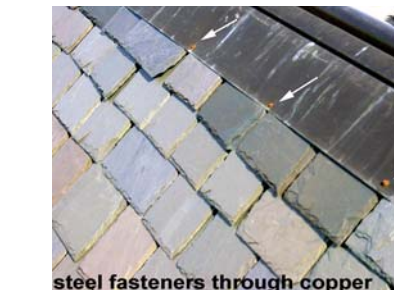
Figure 28: Steel fasteners on copper, as shown, will deteriorate.

**15) USE COMPATIBLE METALS:** A common sight on new slate roof installations is metal incompatibility, often steel and copper used together (Figure 28). The copper will "eat" the steel, causing steel fasteners to degrade at an accelerated rate.

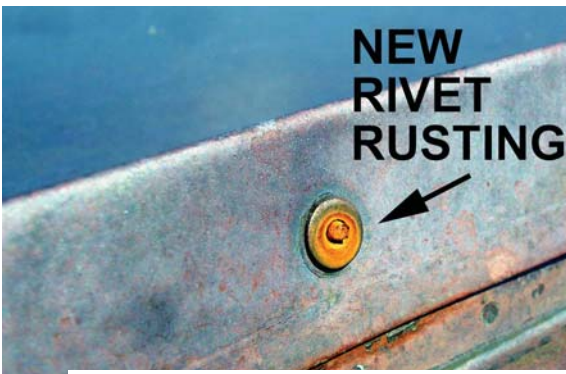
## NEW RIVET RUSTING

Figure 29: Copper rivets with steel mandrels will rust almost immediately, even through a solder joint.

the rivet is installed, the steel mandrel breaks off inside the rivet, lurking there to eventually rust and create a hole in the flashing (Figure 29). These rivets *look* like they're made of copper, but they aren't. Check them with a magnet to be sure. Copper is not magnetic, but steel will stick to a magnet like glue. Copper rivets should have brass mandrels, not steel. If they're magnetic, pitch them.

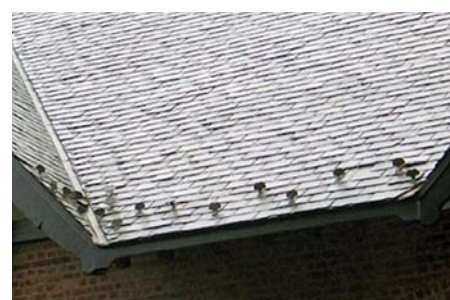
Figure 32: Snowguards must be installed in adequate quantities, or else they will get knocked off in the first bad ice storm and will damage the roof in the process.

**19) USE ENOUGH SNOW GUARDS:** Snow retention systems are another source of problems when they're installed incorrectly. One of the tricks for a proper snowguard installation is to use enough of them. Otherwise, they won't be able to hold the weight of the ice and snow and will rip out, taking slates with them. A poor snowguard installation is shown in Figure 32. The lack of snowguards on this large roof caused many to rip out during an icy winter. Follow the manufacturer's guidelines when installing these popular slate roof elements.

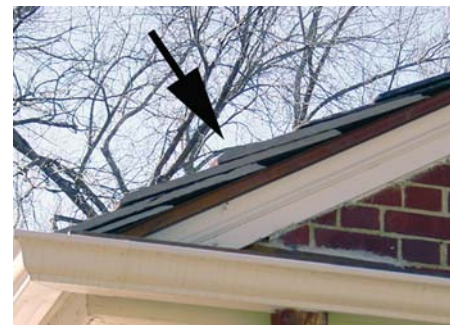
Figure 33: Diamond blades cut a square edge on slates, making them stick out like a sore thumb.

**20) USE THE CORRECT TOOLS:** Incorrect tools can be the downfall of many a would-be slater. Slate roofing has its own unique set of tools and equipment. For example, slates should be cut with, you guessed it — "slate cutters." A slate cutter will leave a beveled edge on the shingle, allowing it to match all the other shingles on the roof, all of which have beveled edges. If a diamond blade is used to cut the slates, a square edge remains, which can stick out like a sore thumb and get a roofer into trouble if the property owner doesn't like the look of it. Figure 33 is a perfect example of square edges exposed at the wrong place on a slate roof. These square edges could be dressed with a slate hammer and stake to give them the proper appearance, but one has to first have these tools in the tool box. When the proper cutter is not on hand, a roofer will resort to drastic measures to try to cut slates, as shown in Figure 34, where it looks like the slates were chewed off by Bigfoot himself. This brand new roof, by the way, also had to be completely removed and reslated, causing the property owner much expense and grief.

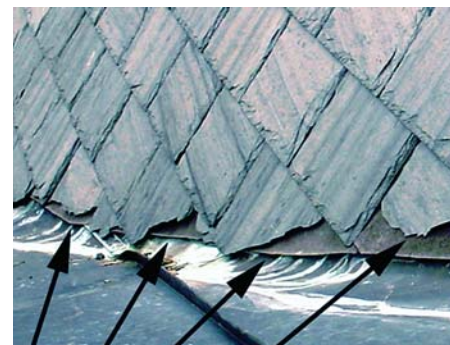
Figure 34: Slate roofing requires the correct tools to do the job right. There is no excuse for the sort of work shown above.

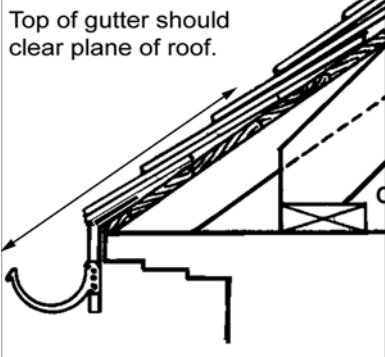
Figure 30: Ideally, the outer edge of external rain gutters should be hung below the plane of the roof to prevent damage to the gutters from sliding ice and snow.

**18) HANG GUTTERS BELOW PLANE OF ROOF:** Speaking of gutters, they're often hung too high. The outer edge of external gutters should be below the plane of the roof (Figure 30) in locations where snow or ice could slide down the roof and knock them off. The gutter in Figure 31, for example, will not last long.

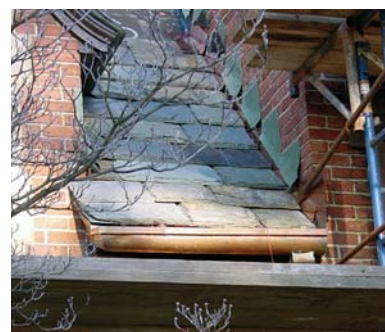
Figure 31: This gutter is just waiting for a snow avalanche to knock it off.
