# HURRICANE FORCE WINDS

## AND HOW THEY AFFECT SLATE ROOFS

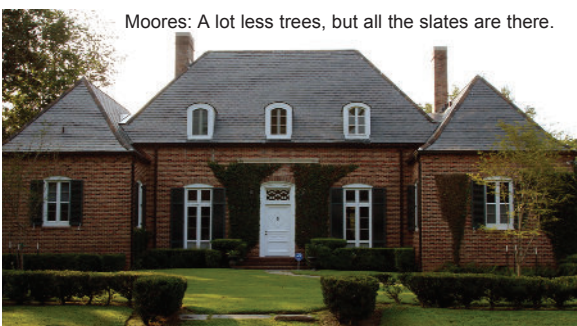
Moores: A lot less trees, but all the slates are there.

The roof damage was nonexistent. That's right — there was no damage to the roof by the hurricane. Not a single slate blew off. As a roof consultant, I had thoroughly inspected

the roof the year before the hurricane. My visit after the hurricane confirmed what seems improbable — no damage to the roof. Installed in 2003, the 50 square roof was made of standard-thickness Vermont gray-black slates, 10" wide and 16" long, from Camara and Sons Slate Company. It was installed on approximately a 12:12 slope, with 11 gauge copper, smooth-shank 1.5" slating nails over a traditional board deck.

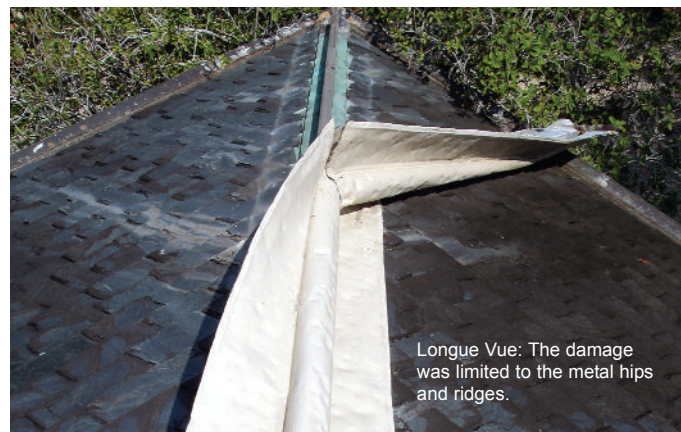
Longue Vue: The damage was limited to the metal hips and ridges.

1942, the roof is made of 14" long, random-width Buckingham slates, 1/4" to 3/4" thick, with a 4" headlap, nailed to a standard board roof deck on approximately a 7:12 slope with smooth-shank copper slating nails. Although there was virtually no damage to the slates themselves, many of the lead-coated copper ridge and hip coverings blew loose. All of the damage was repairable.

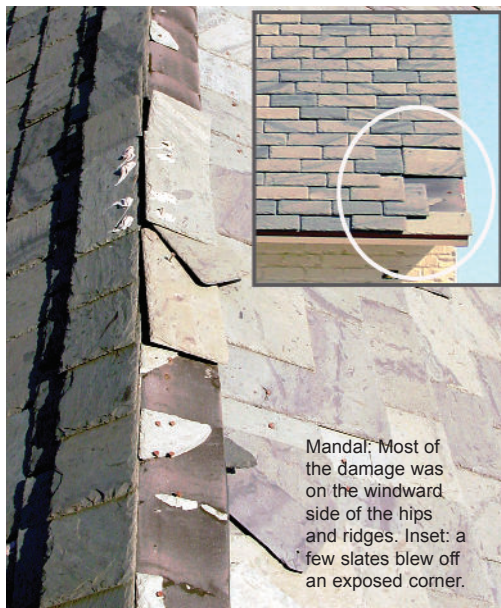
Mandal: Most of the damage was on the windward side of the hips and ridges. Inset: a few slates blew off an exposed corner.

The 136 square Mandal roof, installed in 2004, had a slope ranging from 7:12 to 10:12. It was made of 18" random-width, standard-thickness, unfading gray slate from Evergreen Slate Company, with a 4" headlap, 2" copper smooth-shank slating nails, on a 3/4" plywood deck. It did suffer some damage. The main damage was slates that blew off the saddle hips and ridges, mainly on the windward side. The 7"x14" ridge and hip slates had been nailed with 2" nails also. This roof would have benefitted from 1.5" nails in the field because the 2" nails were too long and broke out the back of the roof decking, effectively diminishing the holding power of the nails (see Figure 2, page 19). The hip and ridge slates, on the other hand, would have benefitted from a more typical 2.5" nail, rather than a 2" nail. There was also some damage in the field of the roof from flying debris. Some slates along some windward edges also blew off. In total, about 250 of the 21,000 slates blew off — about 1.19%, a phenomenally small amount of damage after such a massive assault.
